JBA Project Code	2022s0532
Project Title	Hordle Cliff Assessment
Subject	Preliminary Geotechnical Assessment
Client	New Forest District Council

1 Introduction

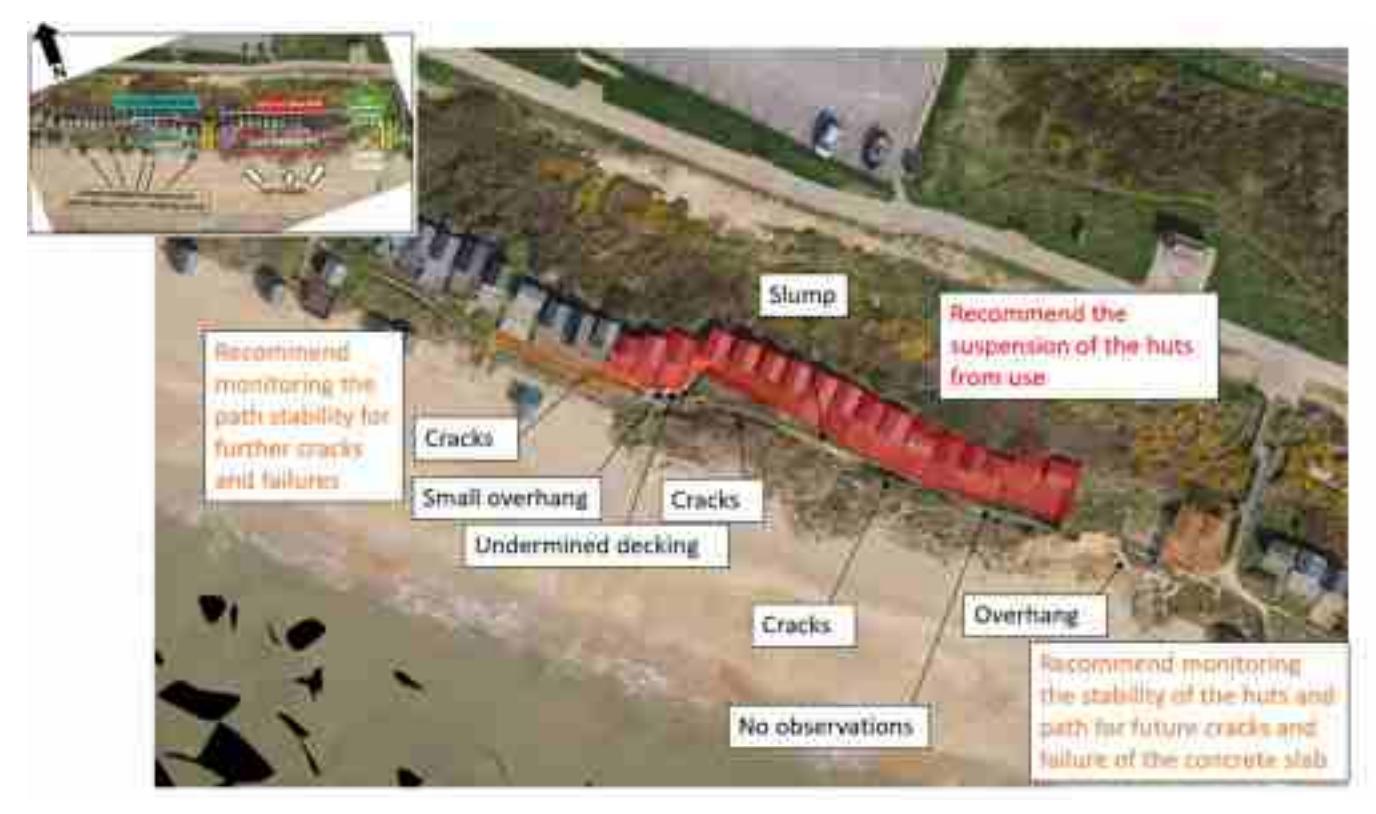
Figure 5-1 Satellite image from UAV topographic survey provided by NFDC. Mark-up shows beach huts at risk, existing failures and advised actions

The areas shaded **red** are where there is immediate risk to these beach huts themselves or the access routes to them and thus, we would advise the suspension of the use of these huts.

The areas highlighted in amber are where the proximity to existing failures or developing tension cracks would suggest it is likely that these huts are at risk in the short to medium term and are particularly at risk in the event of further loss of support to the toe of the escarpment by ongoing beach lowering or storm erosion. On-going monitoring of the slope condition in these areas is recommended.

The remaining unshaded huts on the upper terrace, toward the western end of the site, are located away from current indicators of instability. However, because of the inherent instability of the escarpment as a whole, we would recommend on-going monitoring of the slope condition in these areas, particularly in the event of further loss of support to the toe of the escarpment by ongoing beach lowering or storm erosion.

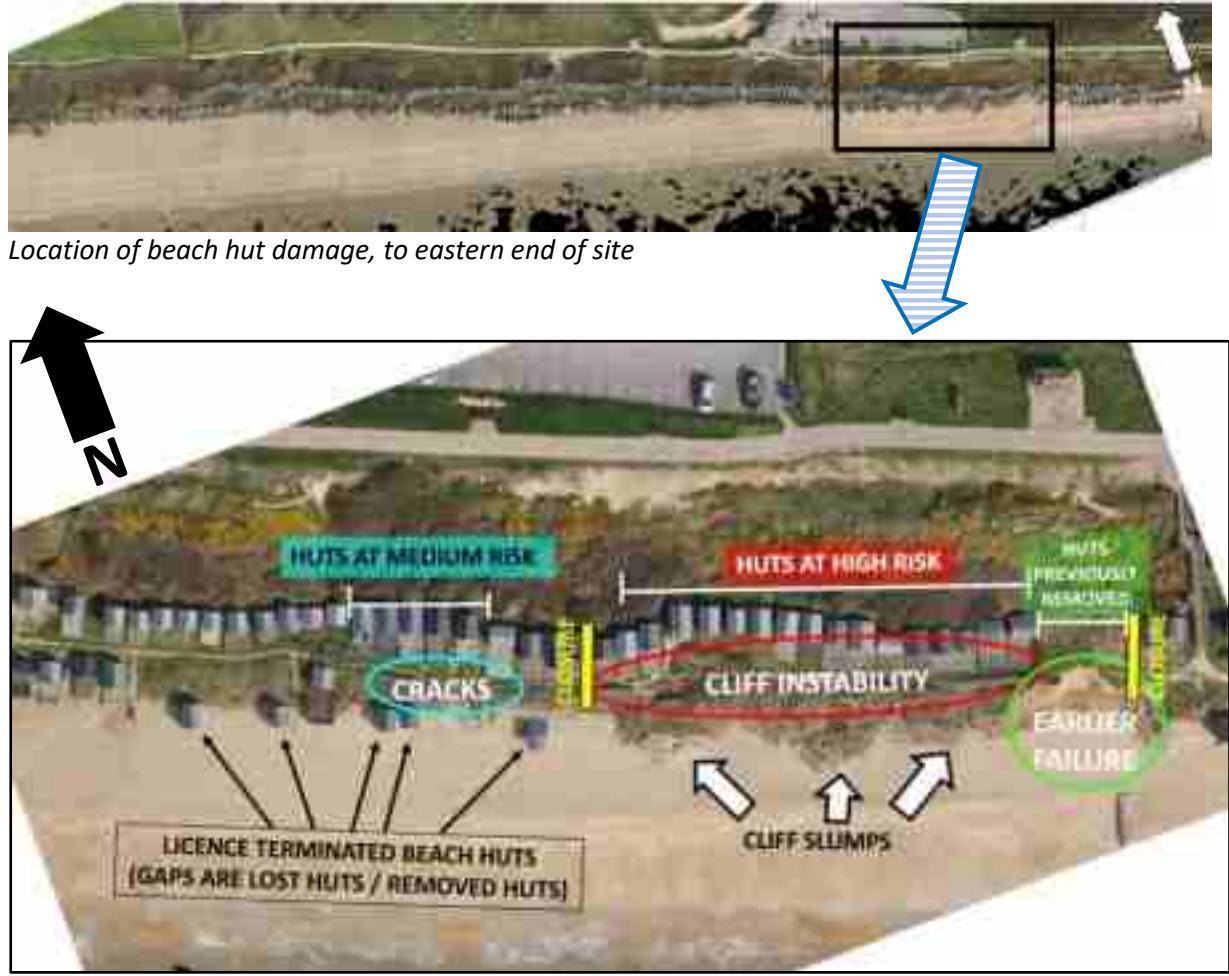
Cliff instability and huts at risk at the eastern end of the site

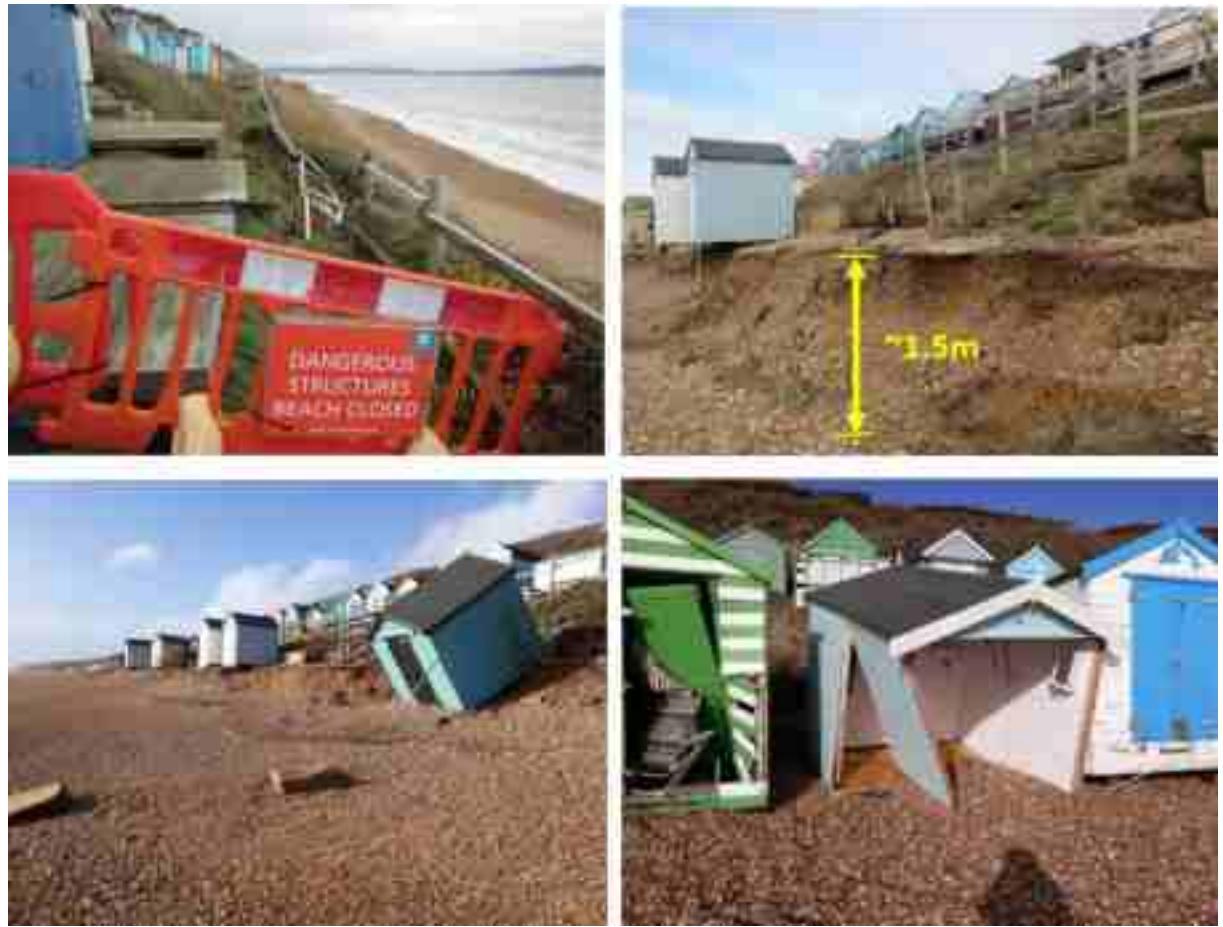
The main structural damage was caused to beach huts to the eastern end of the section where 5no. beach huts were lost completely and around another 25no. damaged (some severely) by wave impact. Once beach levels were lowered, ground instability and movement then quickly ensued in the lower cliff terrace with cliff failures occurring. This instability is now impacting the viability of a number of beach huts located along the cliff and the access to them. Areas have had to be closed off due to safety concerns and the council now needs to look at making some decisions in terms of managing the site.

Location of beach hut damage following Storms Eunice & Franklin, to eastern end of site

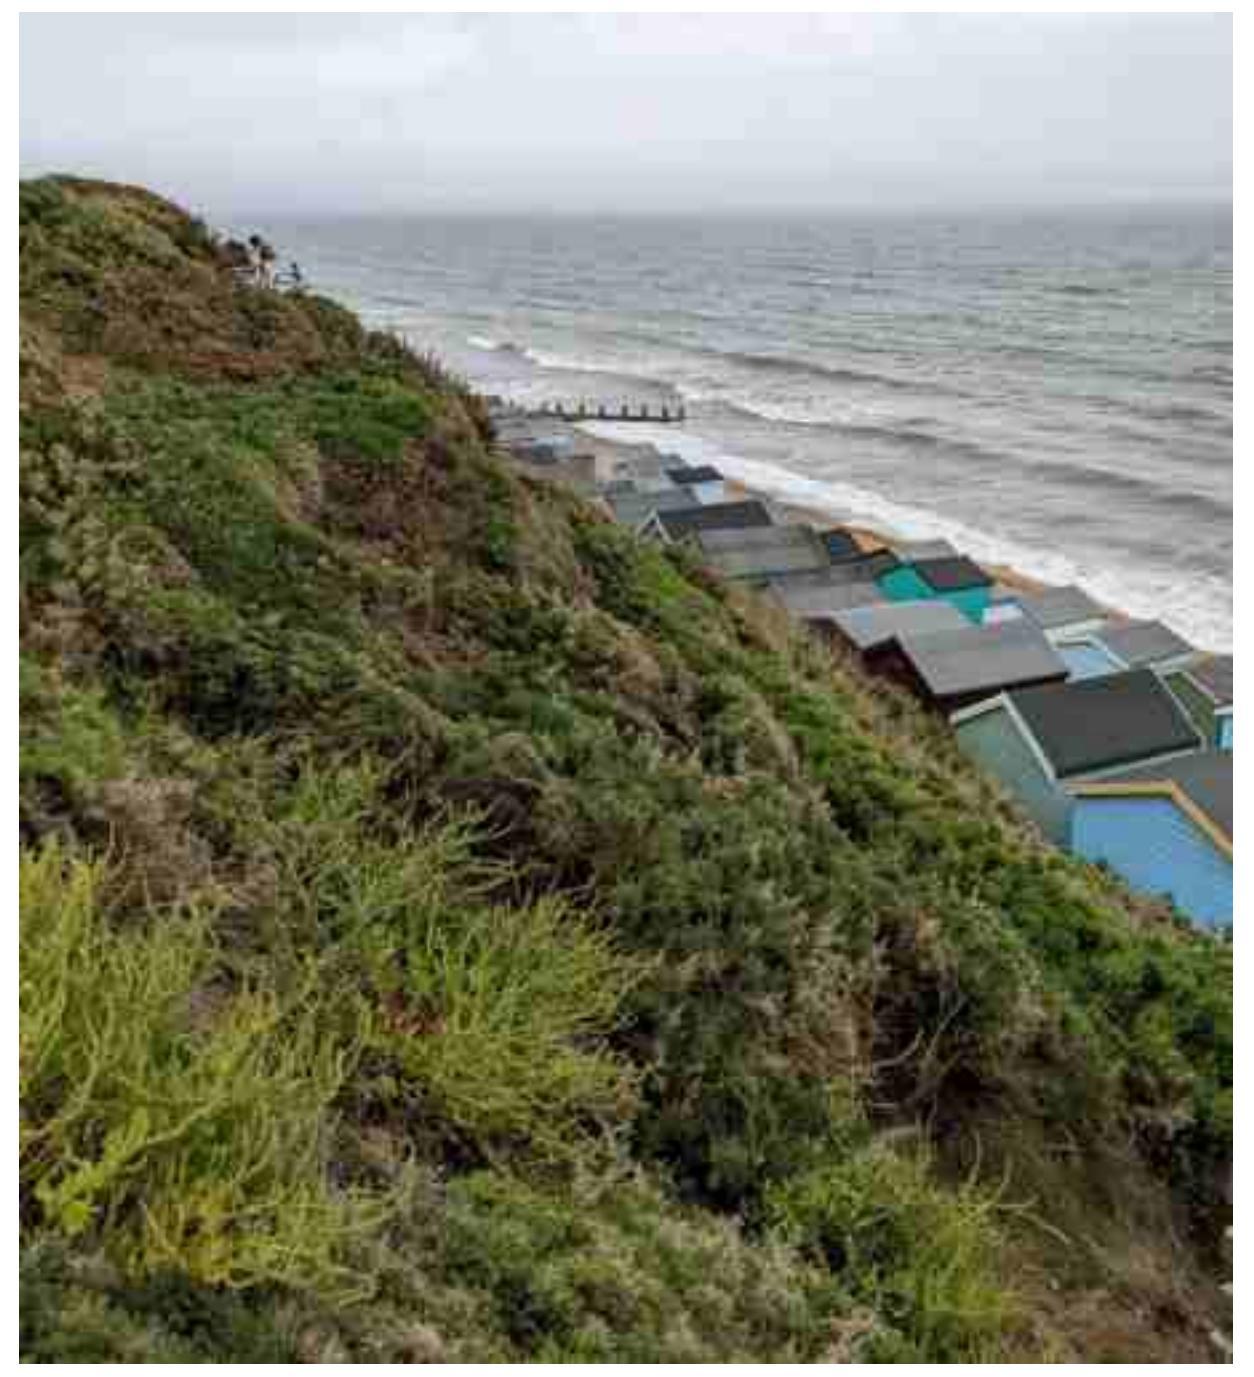
The slope was heavily vegetated (Figure 0-1). This meant that viewing the ground conditions and possible evidence of movement was not always possible. However, the ground conditions were exposed in areas of failure which was noted up at the top of the cliff as well as the larger failures along the toe.

Figure 0-1 Example of a beach hut alignment. Photo taken on 07/06/2022. Approx. Ordnance Survey grid reference SZ 27777 91758.

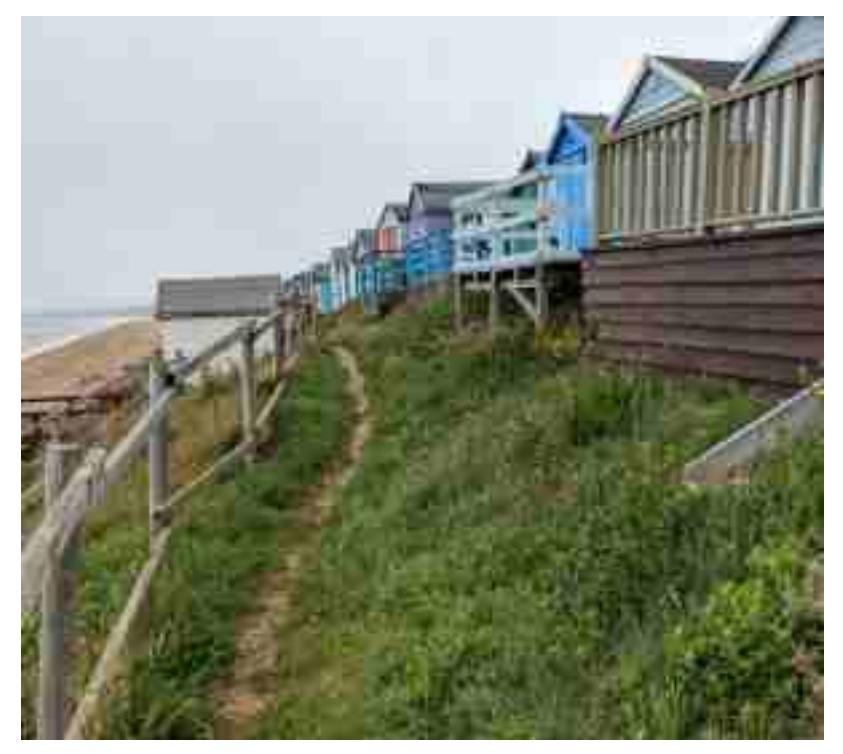
There are two rows of beach huts: one along the toe of the cliff (upper beach terrace) and one up on the lower cliff terrace (Figure 0-2). The majority of the beach huts also have decking. There is slight variation in the alignments of the rows, due to the variable age of the beach huts as the positions have changed over time.

In some areas, the cliff slope had been artificially terraced to allow for the placement of the beach huts and their decking (Figure 0-3). However, in other areas the natural slope of the cliff was visible under the beach hut decking (Figure 0-2).

Figure 0-2 Example of beach hut alignment. Photo taken on 07/06/2022. Approx. Ordnance Survey grid reference SZ 27692 91771.

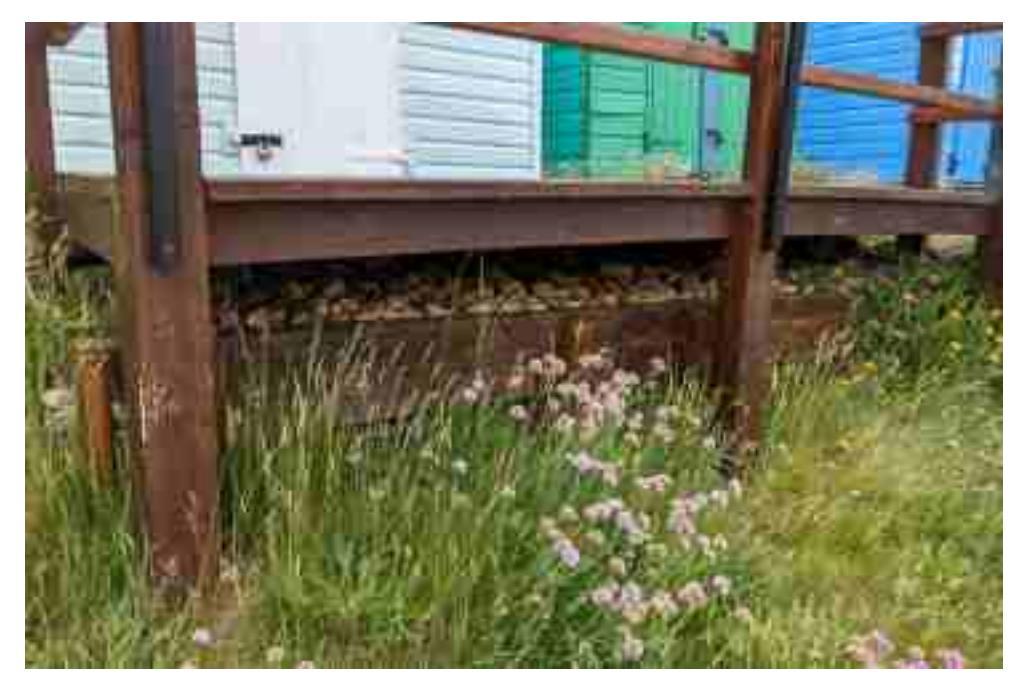
Figure 0-3 Example of ground raised and retained for beach hut and decking placement. Photo taken on 07/06/2022. Approx. Ordnance Survey grid reference SZ 27702 91768.

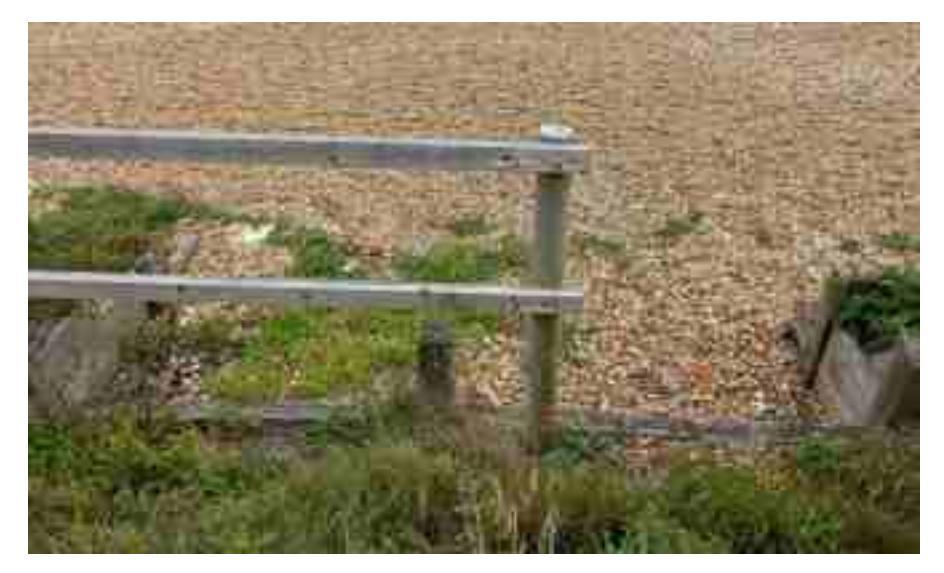
In places some attempts had also been made support the slope behind beach huts. These attempts were seen to typically comprise ad hoc timber post and planking retaining structures, on varying scales, with varying degrees of success. This was evident along both rows of beach huts, but it was easier to access and observe behind huts located along the beach. (Figure 0-4 and Figure 0-5).

Figure 0-4 Example of how beach hut bays have removed toe of the slope and added in ad-hoc retaining structures. This beach hut has been removed due to damage from the February 2022 storms. Photo taken on 07/06/2022. Approx. Ordnance Survey grid reference SZ 27687 91768.

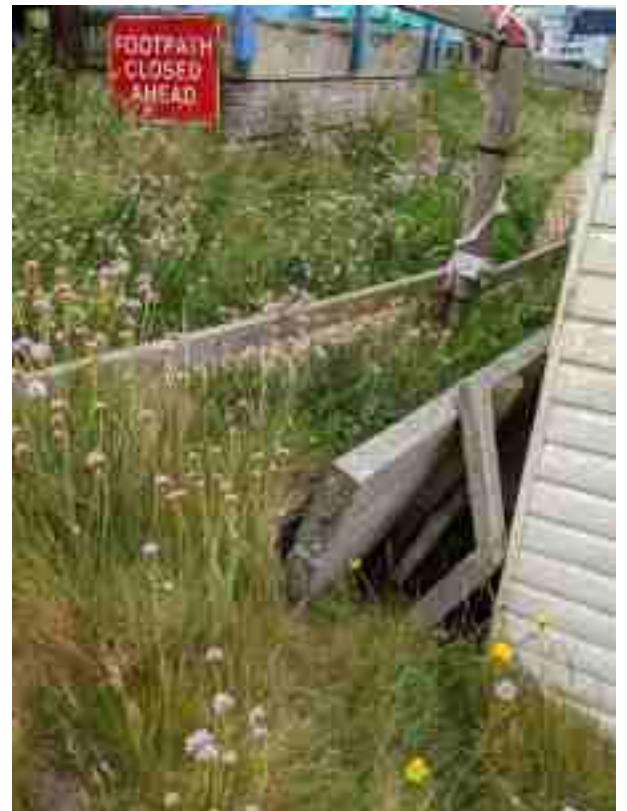
Figure 0-5 Example of failed slope retention at the beach huts along the beach. Photo taken on 07/06/2022. Approx. Ordnance Survey grid reference SZ 27649 91790.

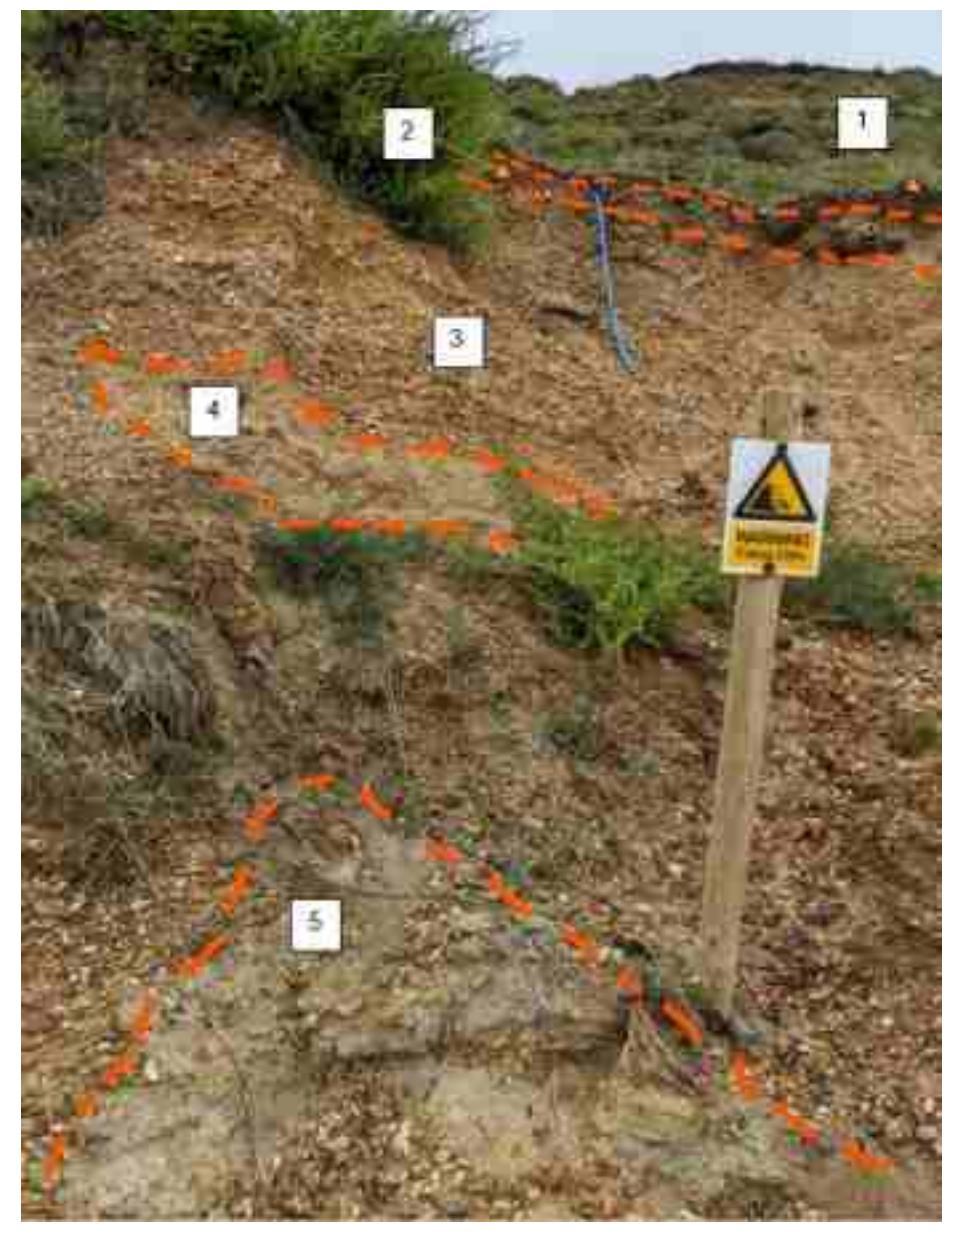
The soils making up the cliff were visible in the section of previous failure (Figure 0-6). There were 5 No. different units observed on site.

- (1) Topsoil Dark grey sandy clay and clayey sand with abundant roots and vegetation.
- (2) Made Ground slightly clayey very sandy Gravel with fragments of brick, plastic piping and blocks of grouted gravel.
- (3) Very sandy gravel with sub-horizontal bedding. The gravel was subrounded to rounded flint.
- (4) Yellow slightly gravelly slightly clayey Sand. Sand is medium to coarse.
- (5) Green-grey mottled red slightly sandy Clay.

Figure 0-6 Photograph showing strata observed on site. Date taken 07/06/2022. Approx. Ordnance Survey grid reference SZ 27757 91744. (Refer to section 3.2).

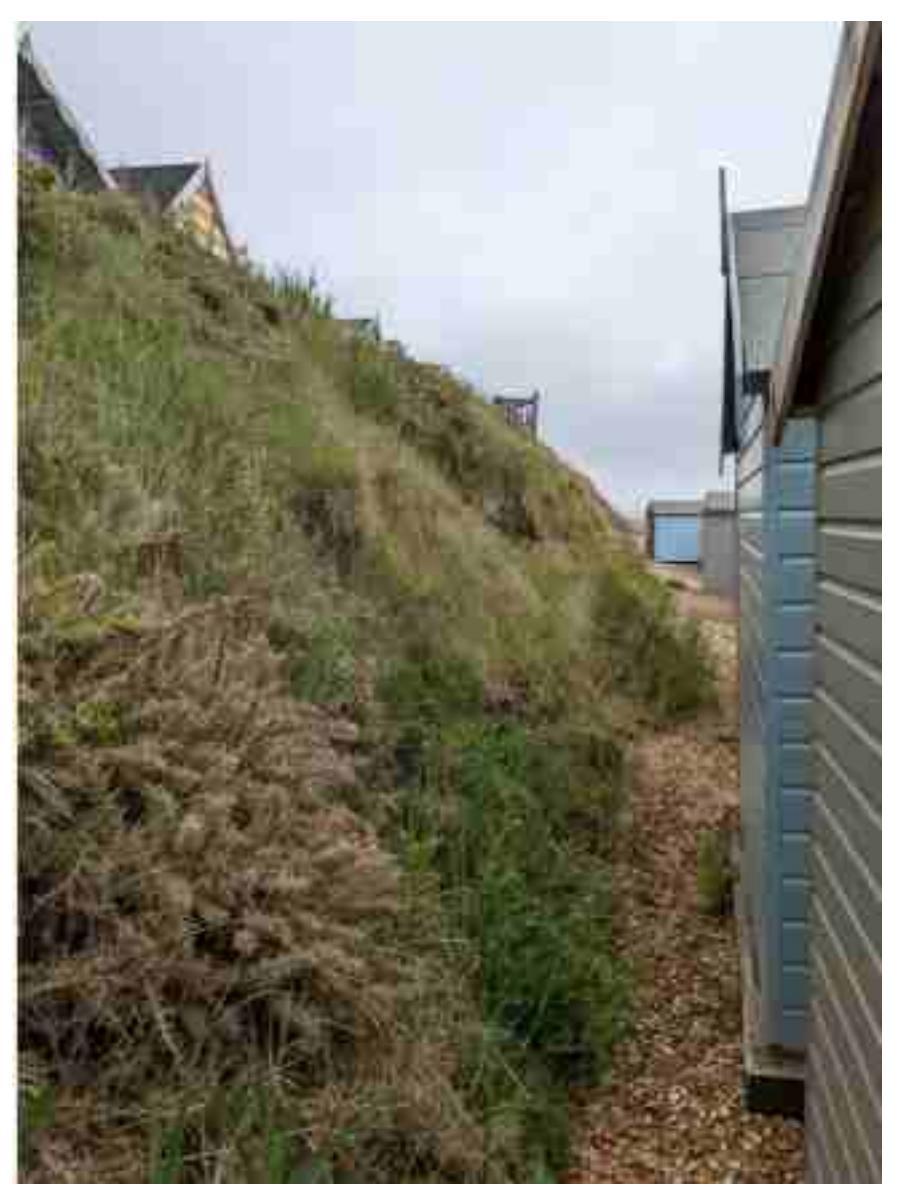
The general impression of the cliff was that the slopes were steep (Figure 0-7). It was difficult to gain an accurate impression due to the thick vegetation and limited accessibility, however measurements were made on exposed surfaces. A total of 6 No. measurements of slope angle were taken across the site, both from the beach and from

the upper terrace of beach huts. The gradient ranged from 28° to 48°. In addition, terracing and retention behind the beach huts had created sub-vertical facets to the slope profile.

Figure 0-7 Photograph showing the slope gradient behind the beach huts on the beach. Date taken 07/06/2022. The photograph was taken behind the beach huts to the east of the area specified in the brief. Approx. Ordnance Survey grid reference SZ 27784 91733.

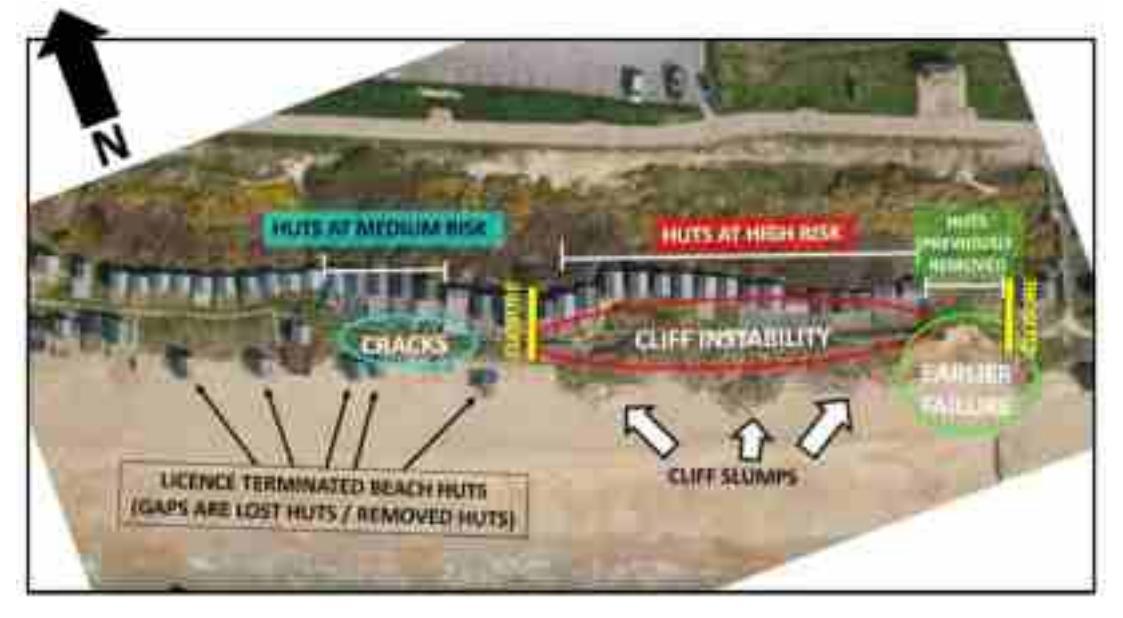
The areas of cliff instability and huts at risk was provided by New Forest District Council brief (Figure 0-8). In addition to the visible movement labelled in Figure 0-8, slips and scars were visible further up the cliff, which can also be seen on aerial photographs.

Figure 0-8 highlights the section of cliff instability. This section has two land slips and one area which has not yet failed, however Figure 0-10 shows a crack appearing at surface. The middle section which has not yet failed appears to have different vegetation compared to the two areas of failure. This may be indicative of different composition and water contents of the soil due to different ground conditions and natural and artificial drainage.

Figure 0-8 Cliff instability and huts at risk at the eastern end of the site (Ref. Geotechnical Assessment_Brief JBA.pdf)

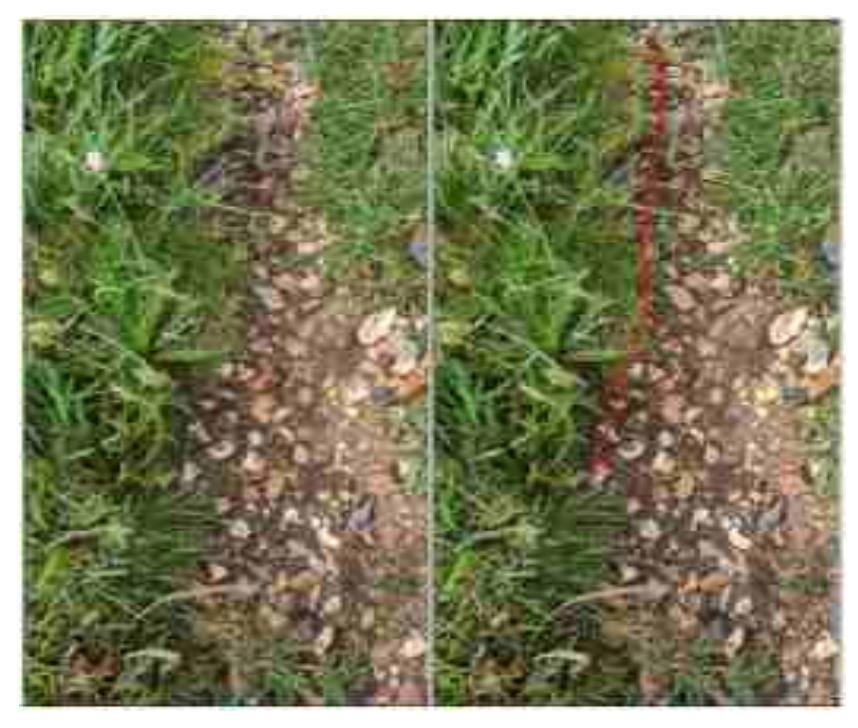
There were some visible cracks along the footpath in the areas labelled 'cracks' (Figure 0-9) and in the 'cliff instability' area between the labelled cliff slumps (Figure 0-10). The crack shown in Figure 0-11 is to the east of the eastern cliff slump in the 'cliff instability' section. The visible cracks showed small vertical displacement (mm scale) and indicate shallow translational failure.

Figure 0-9 Photo of crack, taken 07/06/2022. Approx. Ordnance Survey grid reference SZ 27704 91768.

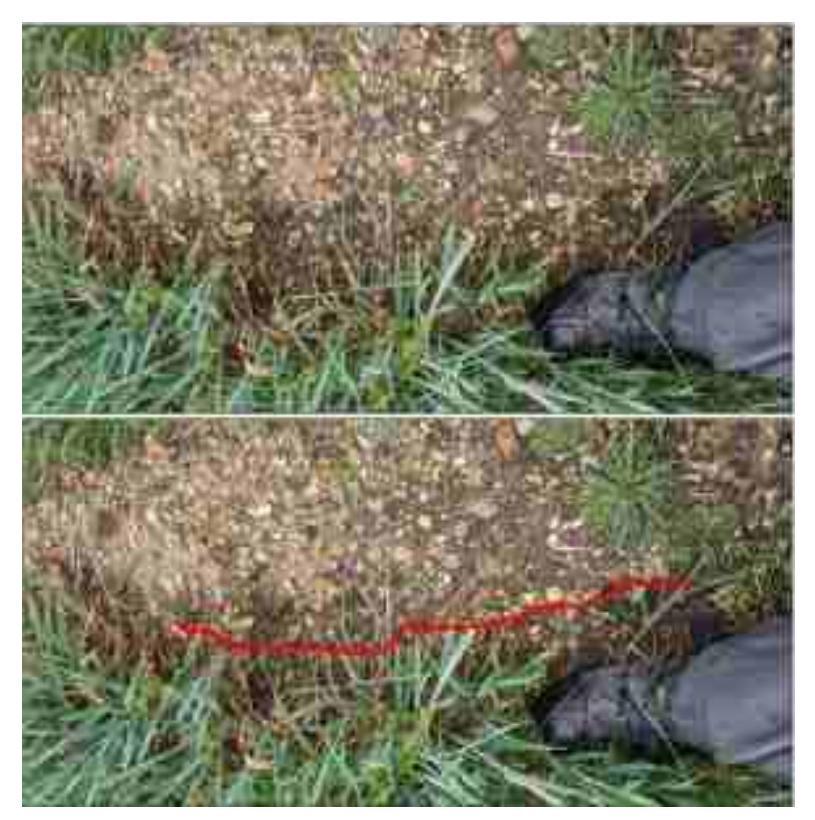
Figure 0-10 Photo of crack, taken 07/06/2022. Approx. Ordnance Survey grid reference SZ 27720 91763.

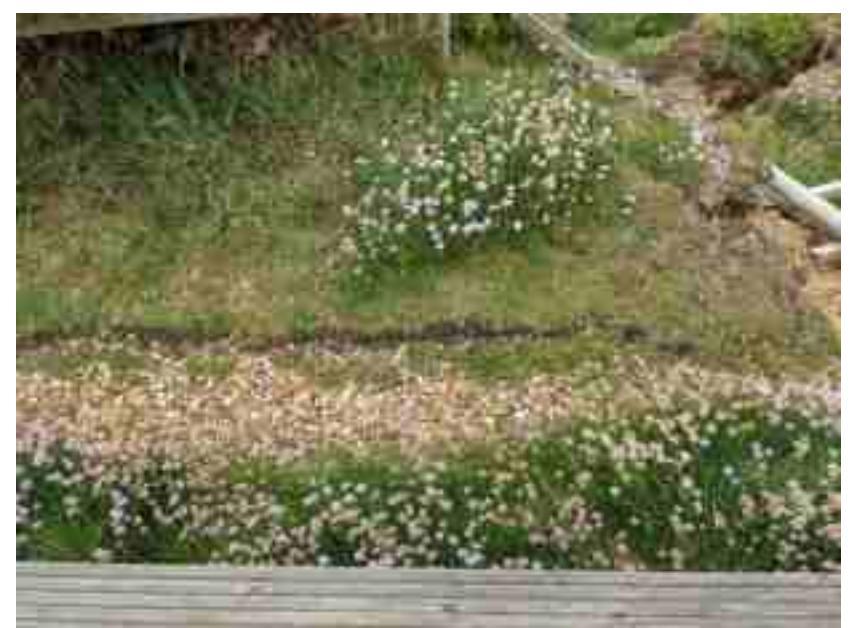
Figure 0-11 Photo of crack, taken 07/06/2022. Approx. Ordnance Survey grid reference SZ 27755 91751.

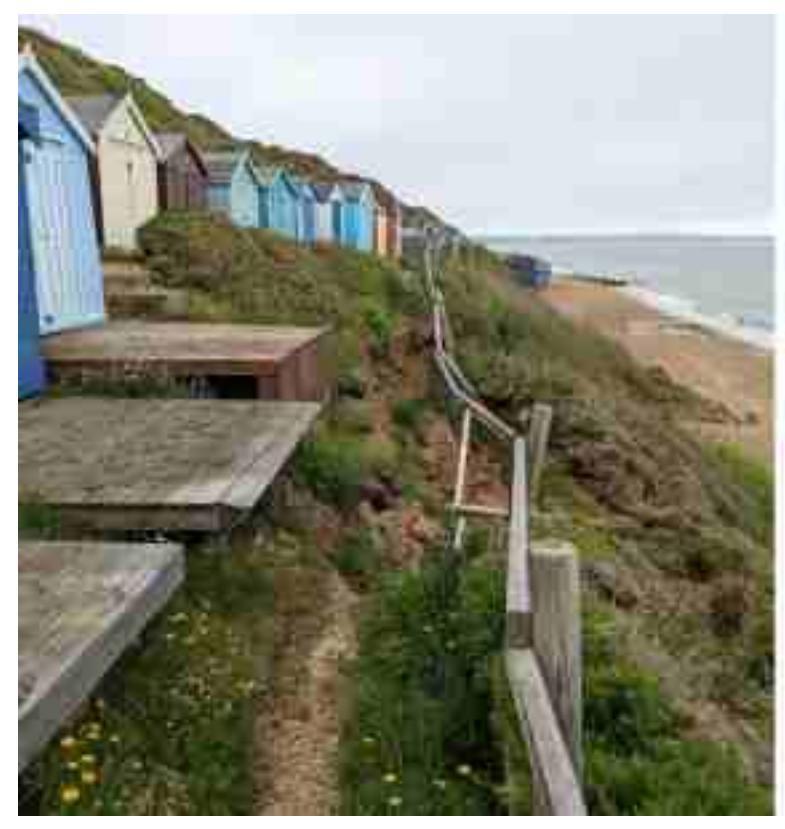
Figure 0-12 Photo of western cliff slump. Photo taken 07/06/2022. Approx. Ordnance Survey grid reference SZ 27709 91766.

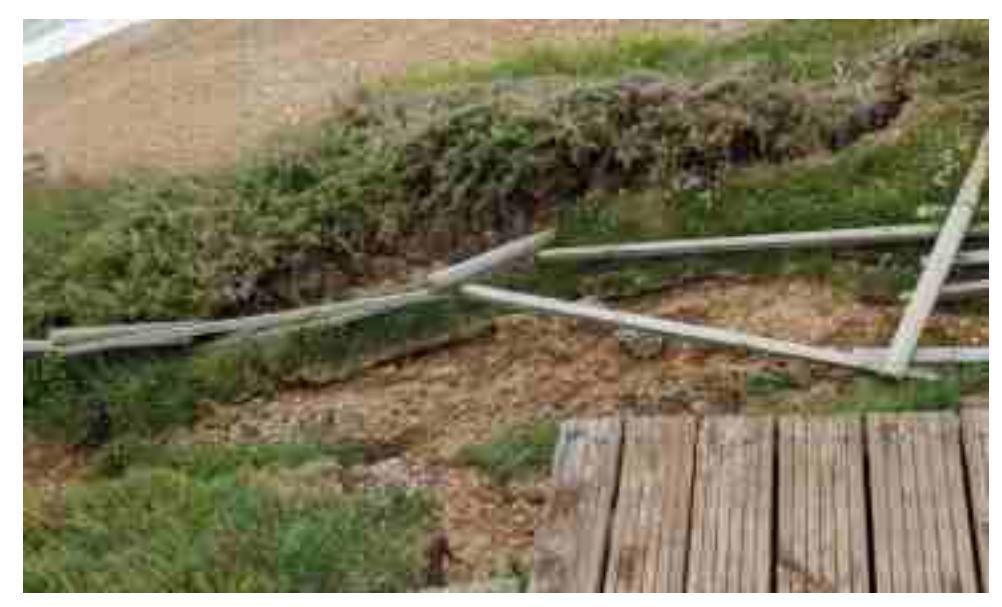
Figure 0-13 Photo of crack at the top of the western cliff slump. Photo taken 07/06/2022. Approx. Ordnance Survey grid reference SZ 27711 91767.

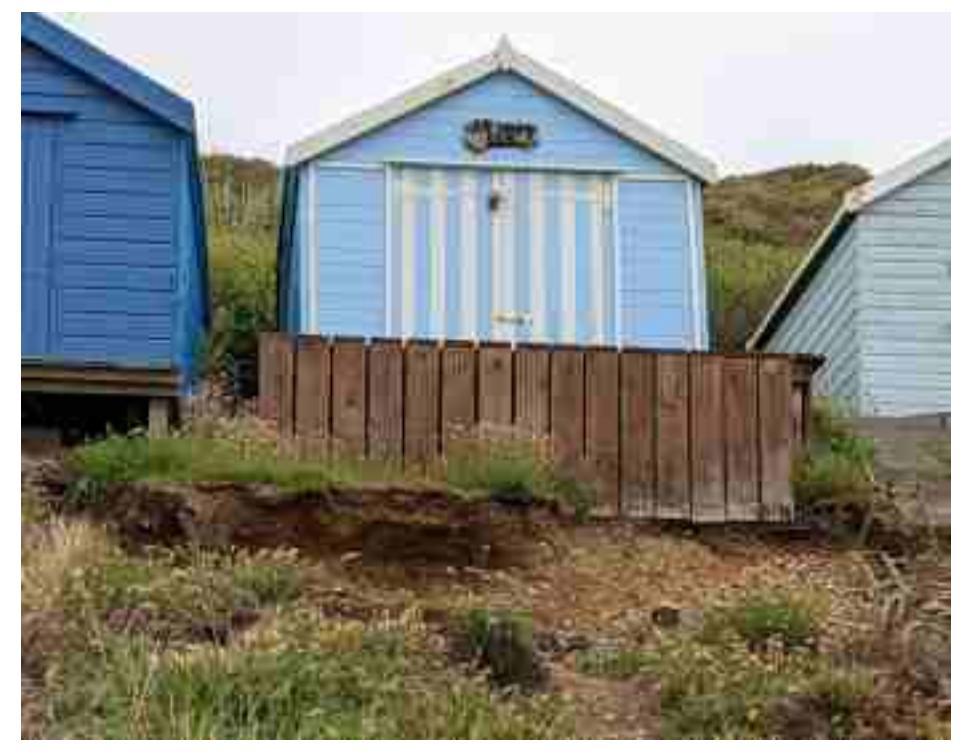
Figure 0-14 Photo of the overhang and undermining of the beach hut decking at the western cliff slump. Photo taken 07/06/2022. Approx. Ordnance Survey grid reference SZ 27708 91760.

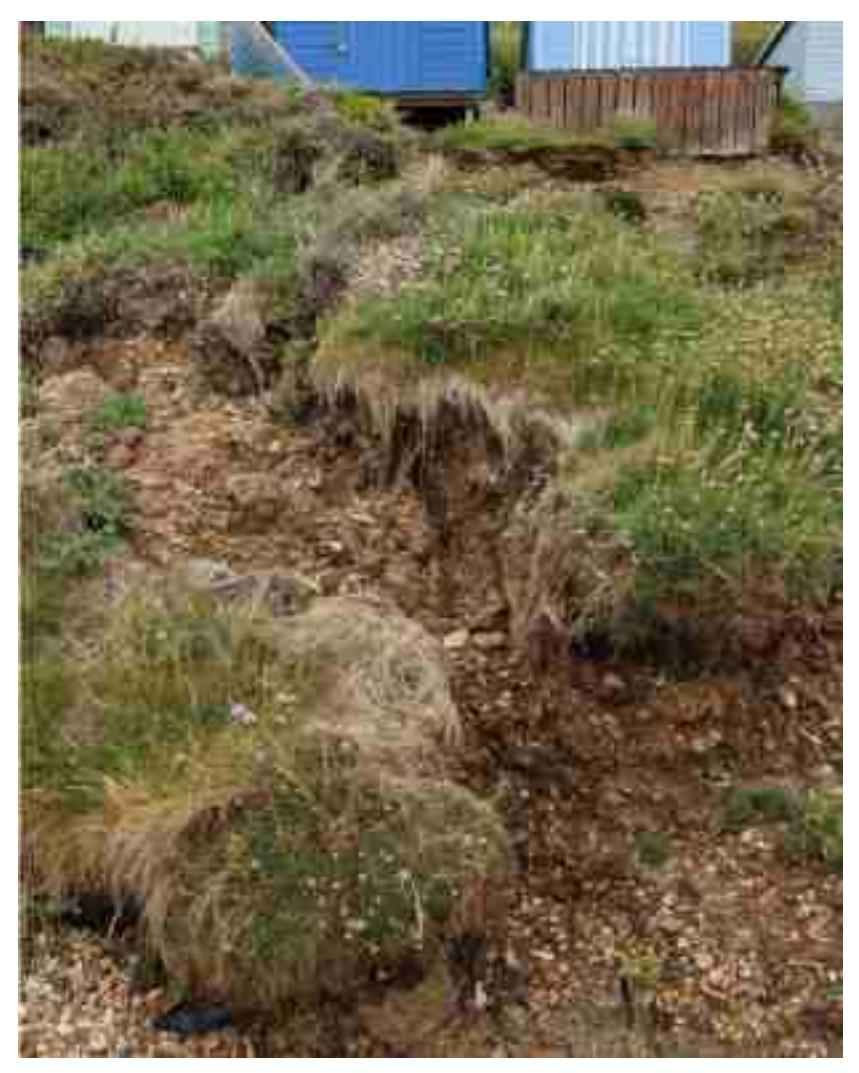
Figure 0-15 Photo of the slumped material at the western cliff slump. Photo taken 07/06/2022. Approx. Ordnance Survey grid reference SZ 27708 91760.

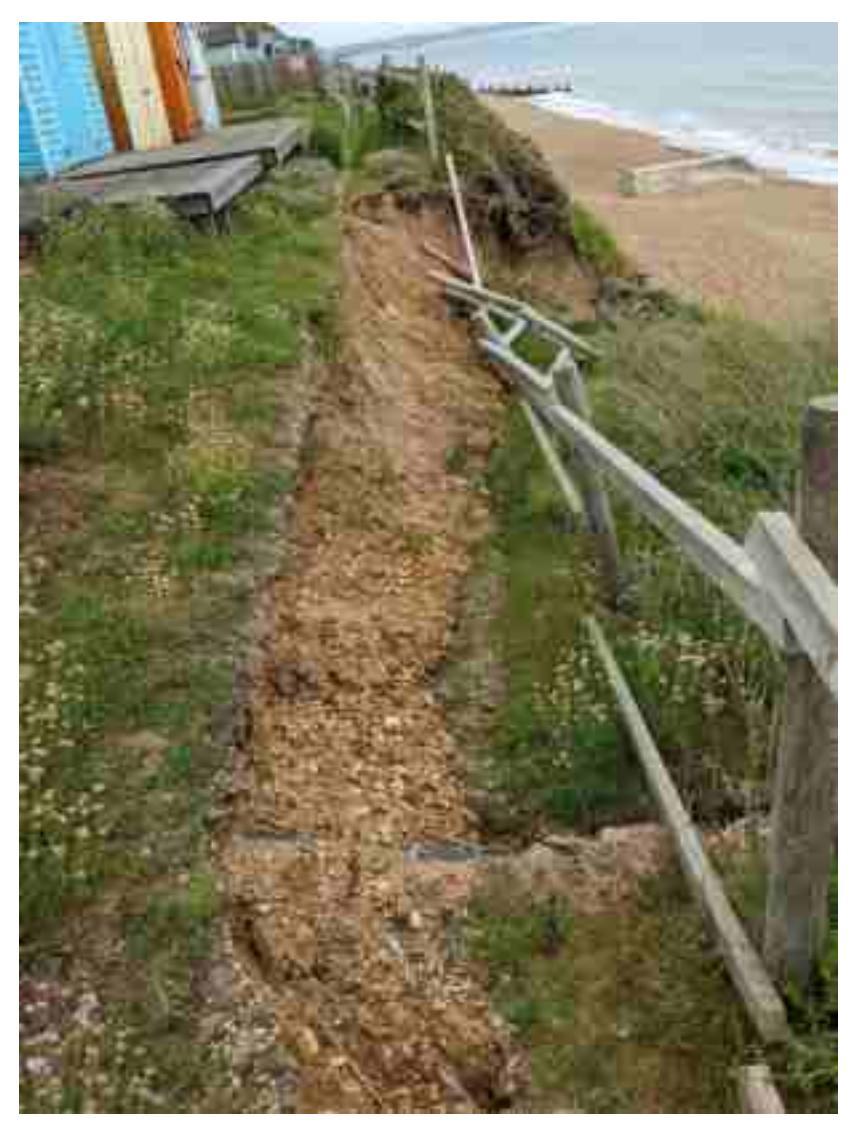
Figure 0-16 Photo of second cliff slump. Photo taken 07/06/2022. Approx. Ordnance Survey grid reference SZ 27732 91757.

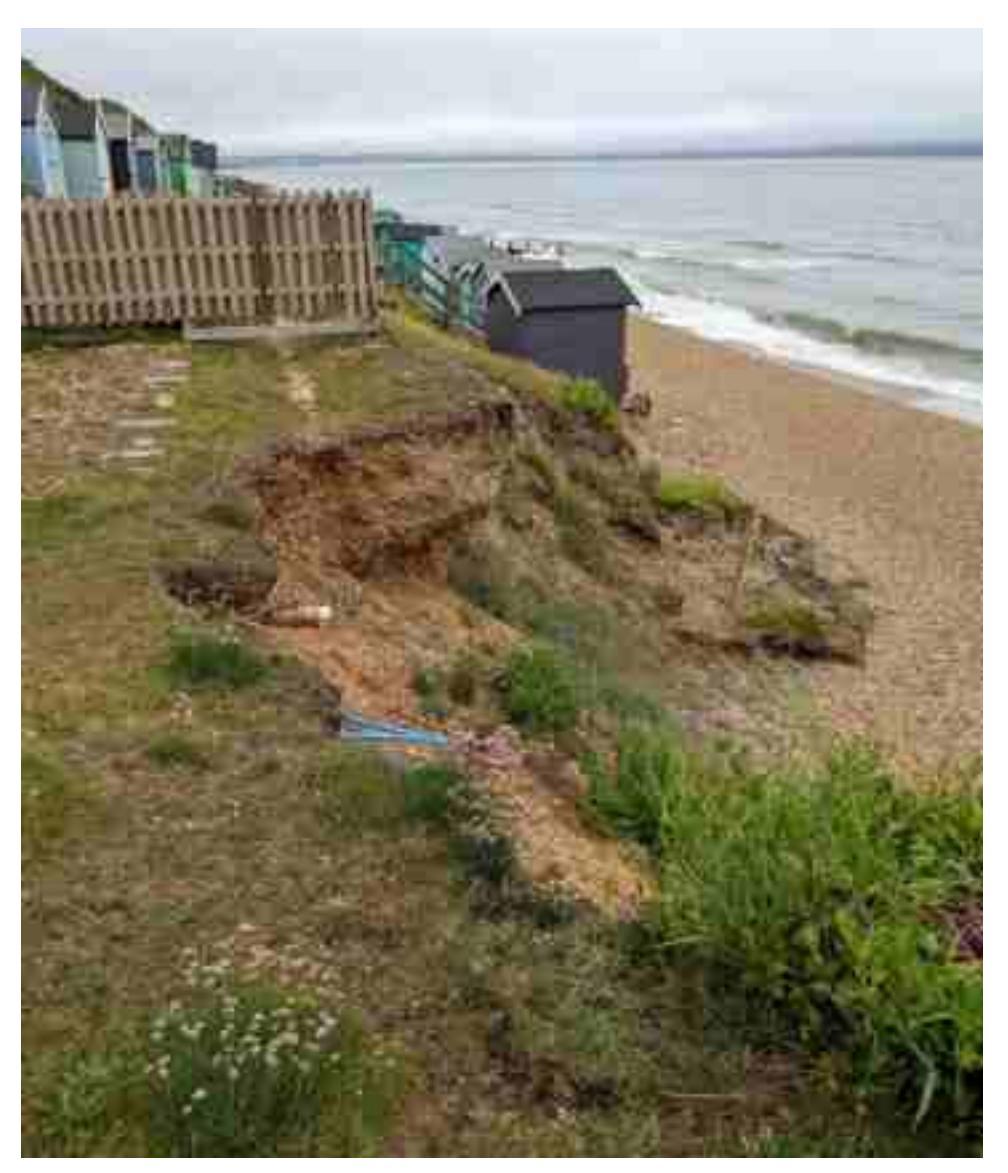
Figure 0-17 Photo of earlier failure. Photo taken 07/06/2022. Approx. Ordnance Survey grid reference SZ 27753 91752.

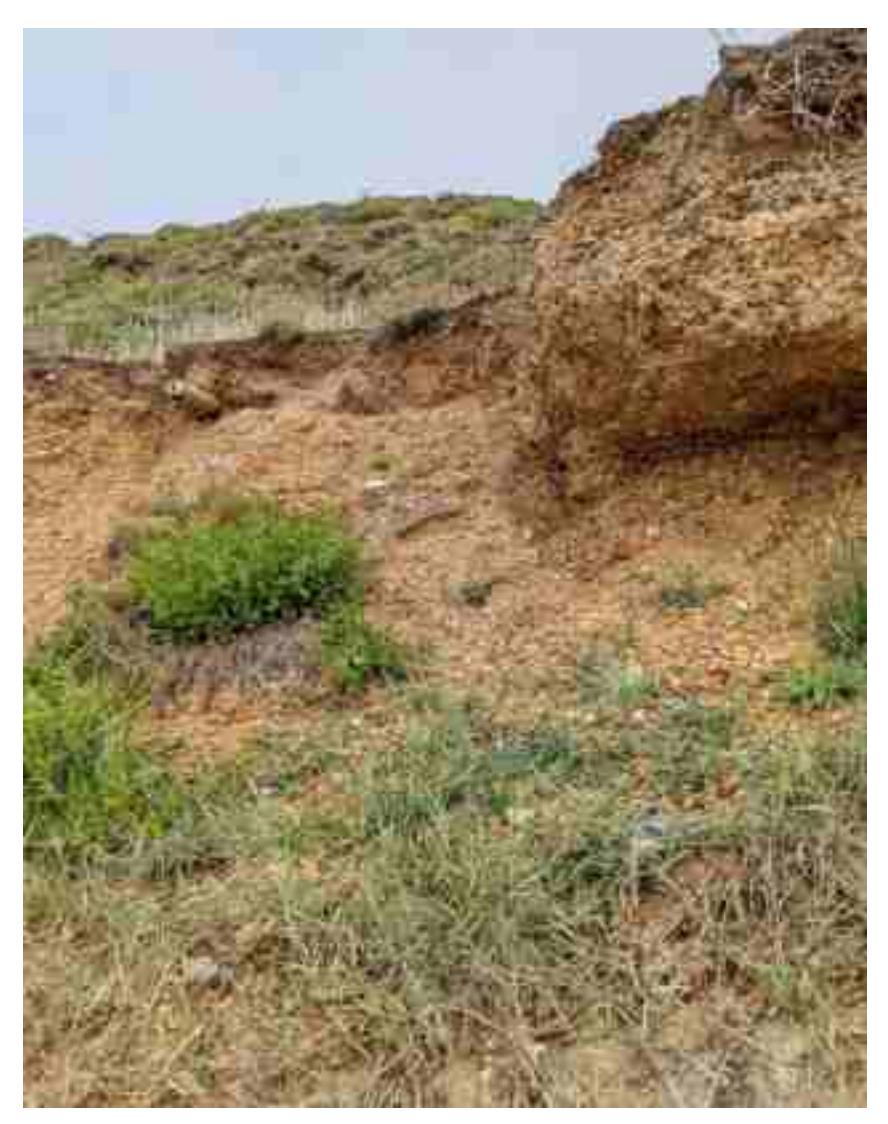
In the areas of failure, there were several exposed plastic pipes for drainage and water supply. The previous failure (Figure 0-18) had areas of darker soils underneath the cemented block/overhang which indicated a 'wet' layer which could have resulted from natural preferential drainage through the soil layers. This was also notable in the clay layer at this location, as the Client commented on site that the clay at the toe of the cliff in this location remained wet even after periods of good weather.

Figure 0-18 Photo of earlier failure showing pipe, cemented overhang and water line. Photo taken 07/06/2022. Approx. Ordnance Survey grid reference SZ 27757 91743.

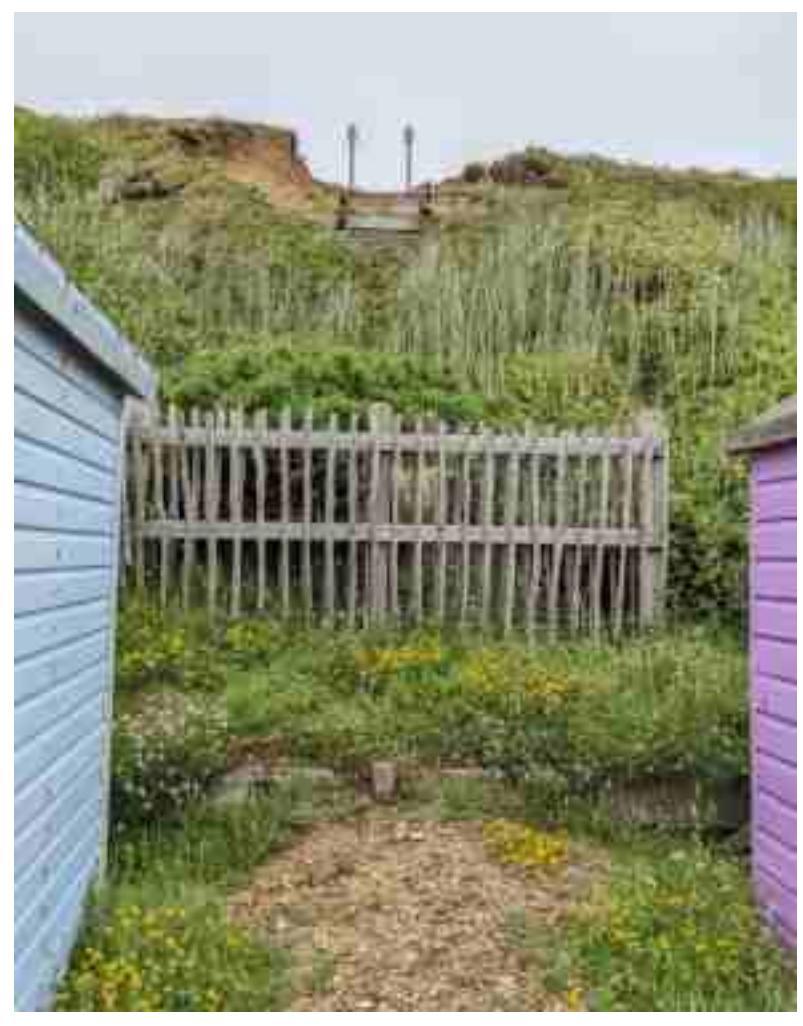
Figure 0-19 Photo of other failure higher up the slope. Photo taken 07/06/2022. Approx. Ordnance Survey grid reference SZ 27642 91794.

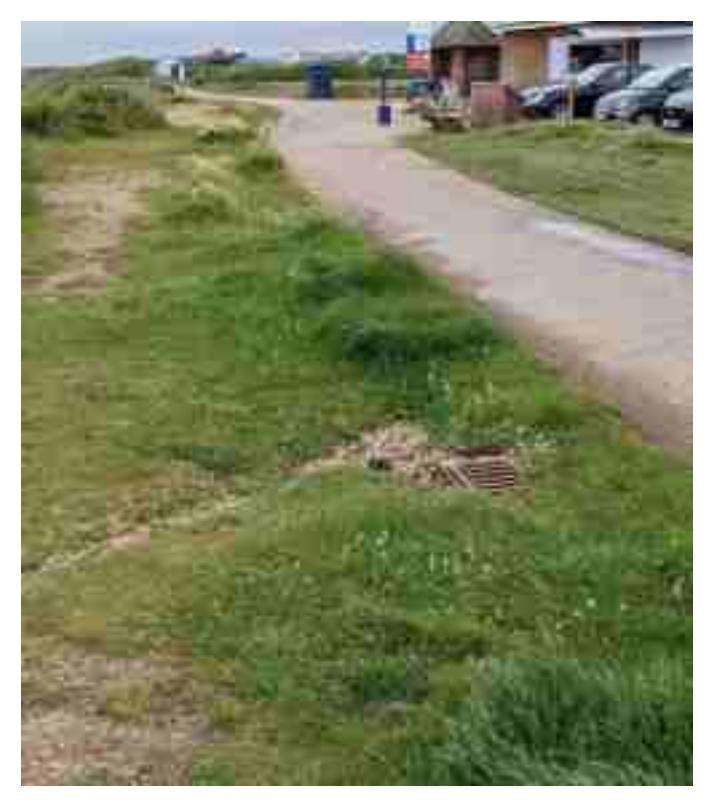
Artificial drainage pipes have been installed throughout the cliff although there is no formal record. At the top of the cliff, there are drains with exposed geotextile at the top of a failed section of cliff (Figure 0-20). There was also geotextile exposed on the footpath along the second row of beach huts near the crack shown in Figure 0-10. This may indicate the presence of drainage in the area or may be from the founding of some beach huts.

Figure 0-20 Photo of drainage at the top of the cliff, taken 07/06/2022. Approx. Ordnance Survey grid reference SZ 27649 91814.

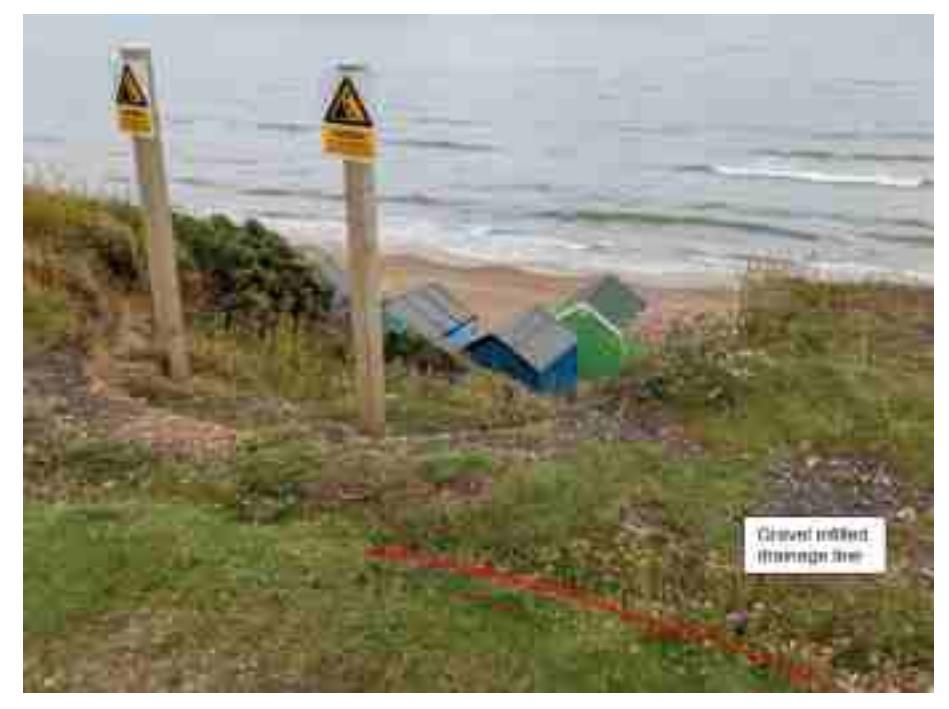
Figure 0-21 Photo of failure at the top of the cliff, adjacent to the drainage channel, taken 07/06/2022. Approx. Ordnance Survey grid reference SZ 27649 91814.
