JBA Project Code	2022s0532
Project Title	Hordle Cliff Assessment
Subject	Preliminary Geotechnical Assessment
Client	New Forest District Council

1 Introduction

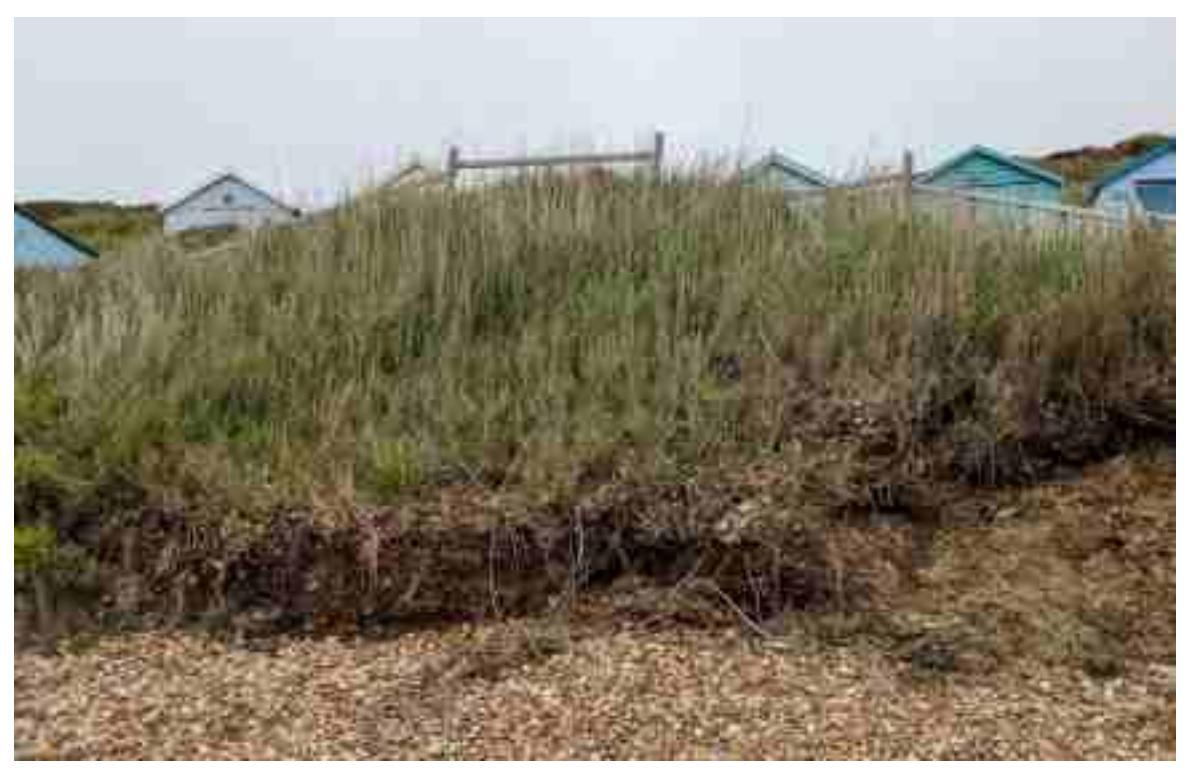
Figure 0-22 Photo of unsupported toe of the slope in the middle cliff slump area. Photo taken 07/06/2022. Approx. Ordnance Survey grid reference SZ 27730 91751.
