Calshot Erosion Works Completion Note: 26th November 2024

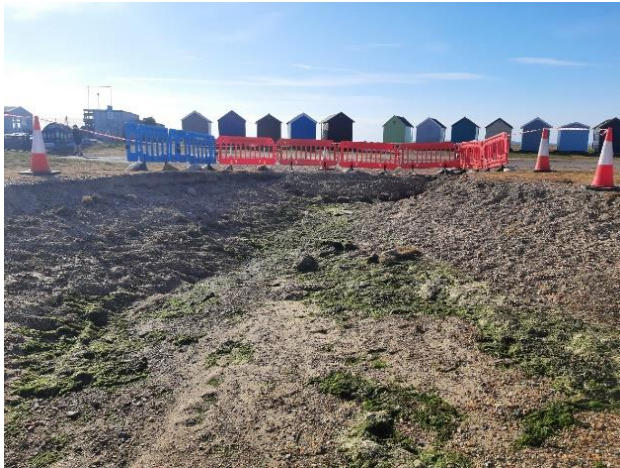
Figure 1 – Eroded Area (NFDC Land)

Work was undertaken on Tuesday 5th November 2024 to repair an area of the foreshore on the north-western (lee) side of Calshot Spit. This area was impacted on the 8th & 9th of April 2024 when near record high tides, combined with strong winds & waves, eroded a deep gully to within less than 3m of Jack Maynard Road (a key access road, and the only route along Calshot Spit).

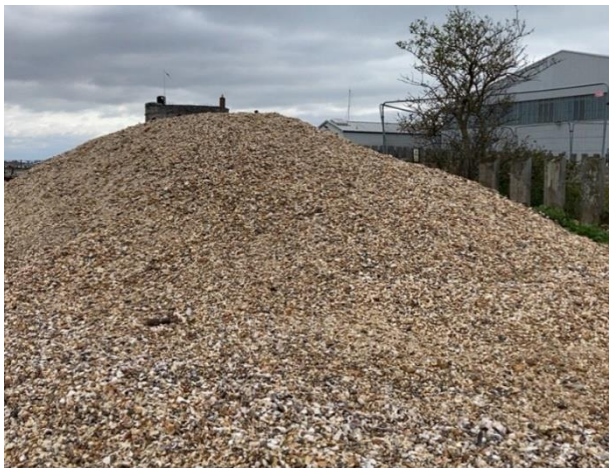
Figure 3 – Shingle Stockpile (HCC Land)

Due to the potential impacts and interests to both NFDC & HCC, officers from both the NFDC Coastal Group and HCC Calshot Activities Centre worked together to facilitate a combined response, which involved transferring shingle material from the tip of Calshot Spit to repair the impacted area. This material had previously been cleared from the RNLi slipway into a heap located adjacent to the RNLi slipway. The shingle was loaded by a JCB, and a small (9T) dump truck undertook 14 repeat journeys through the Activities Centre site to the eroded area. Around 135T of shingle was transferred to the eroded area. The shingle was graded to reconstruct the slope profile to match adjacent areas.

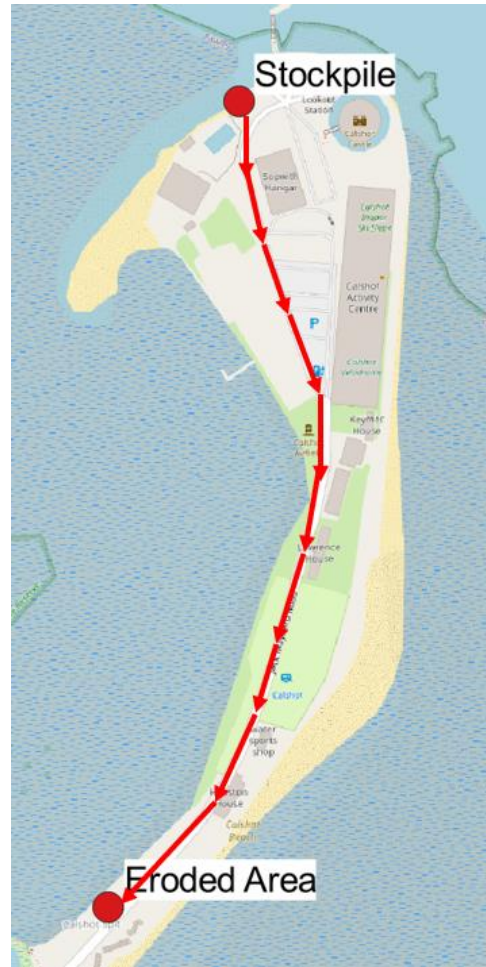
Figure 2 – Transfer route

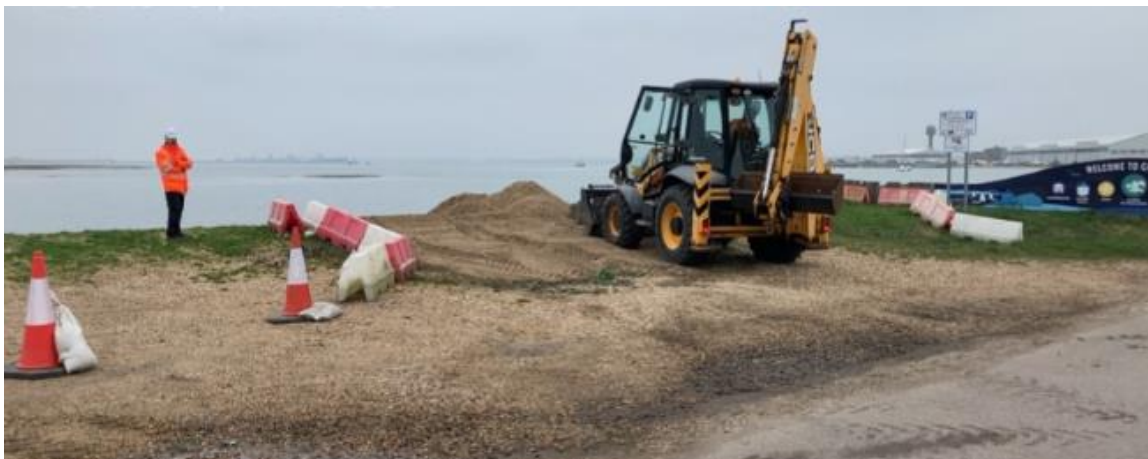
Figure 4 HCC & NFDC operatives working to infill eroded areas

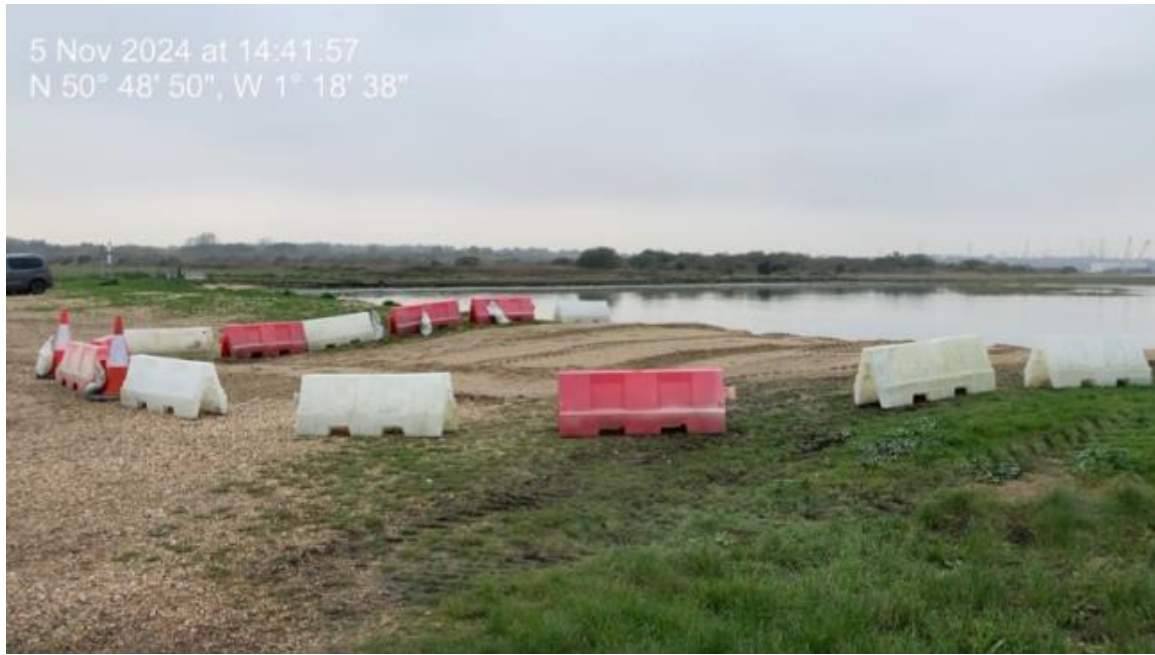
Figure 4 – Completed works: barriers remained in place to allow settlement

By working together, NFDC and HCC avoided the need to use contractors and therefore significant cost savings were made. Following completion of the works, barriers were placed around the infilled area to allow settlement to take place. The area is now back under the management of NFDC Car Parking Team, and the barriers have now been removed.
