JBA Project Code	2022s0532
Project Title	Hordle Cliff Assessment
Subject	Preliminary Geotechnical Assessment
Client	New Forest District Council

1 Introduction

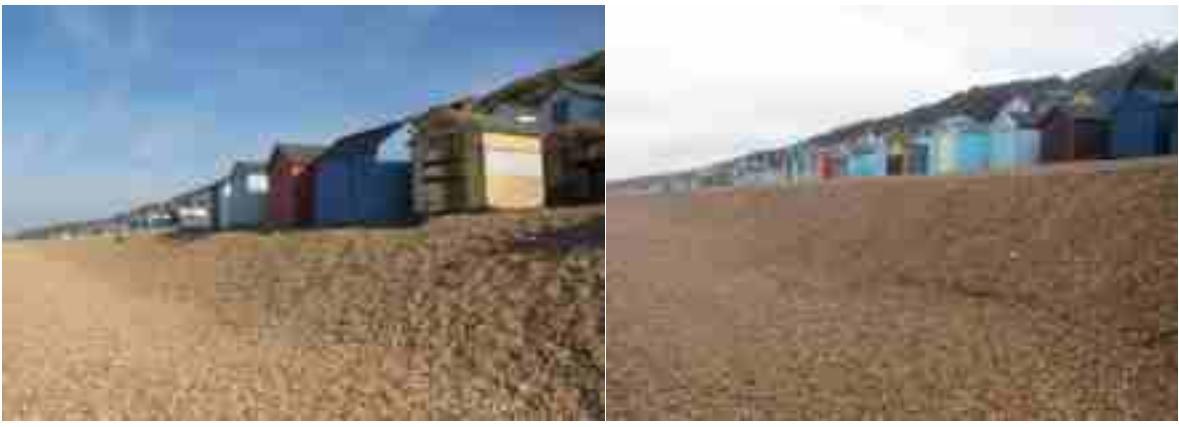
General arrangement of beach huts (2 rows: one on the beach and one on the lower cliff)

The main structural damage was caused to beach huts to the eastern end of the section where 5no. beach huts were lost completely and around another 25no. damaged (some severely) by wave impact. Once beach levels were lowered, ground instability and movement then quickly ensued in the lower cliff terrace with cliff failures occurring. This instability is now impacting the viability of a number of beach huts located along the cliff and the access to them. Areas have had to be closed off due to safety concerns and the council now needs to look at making some decisions in terms of managing the site.

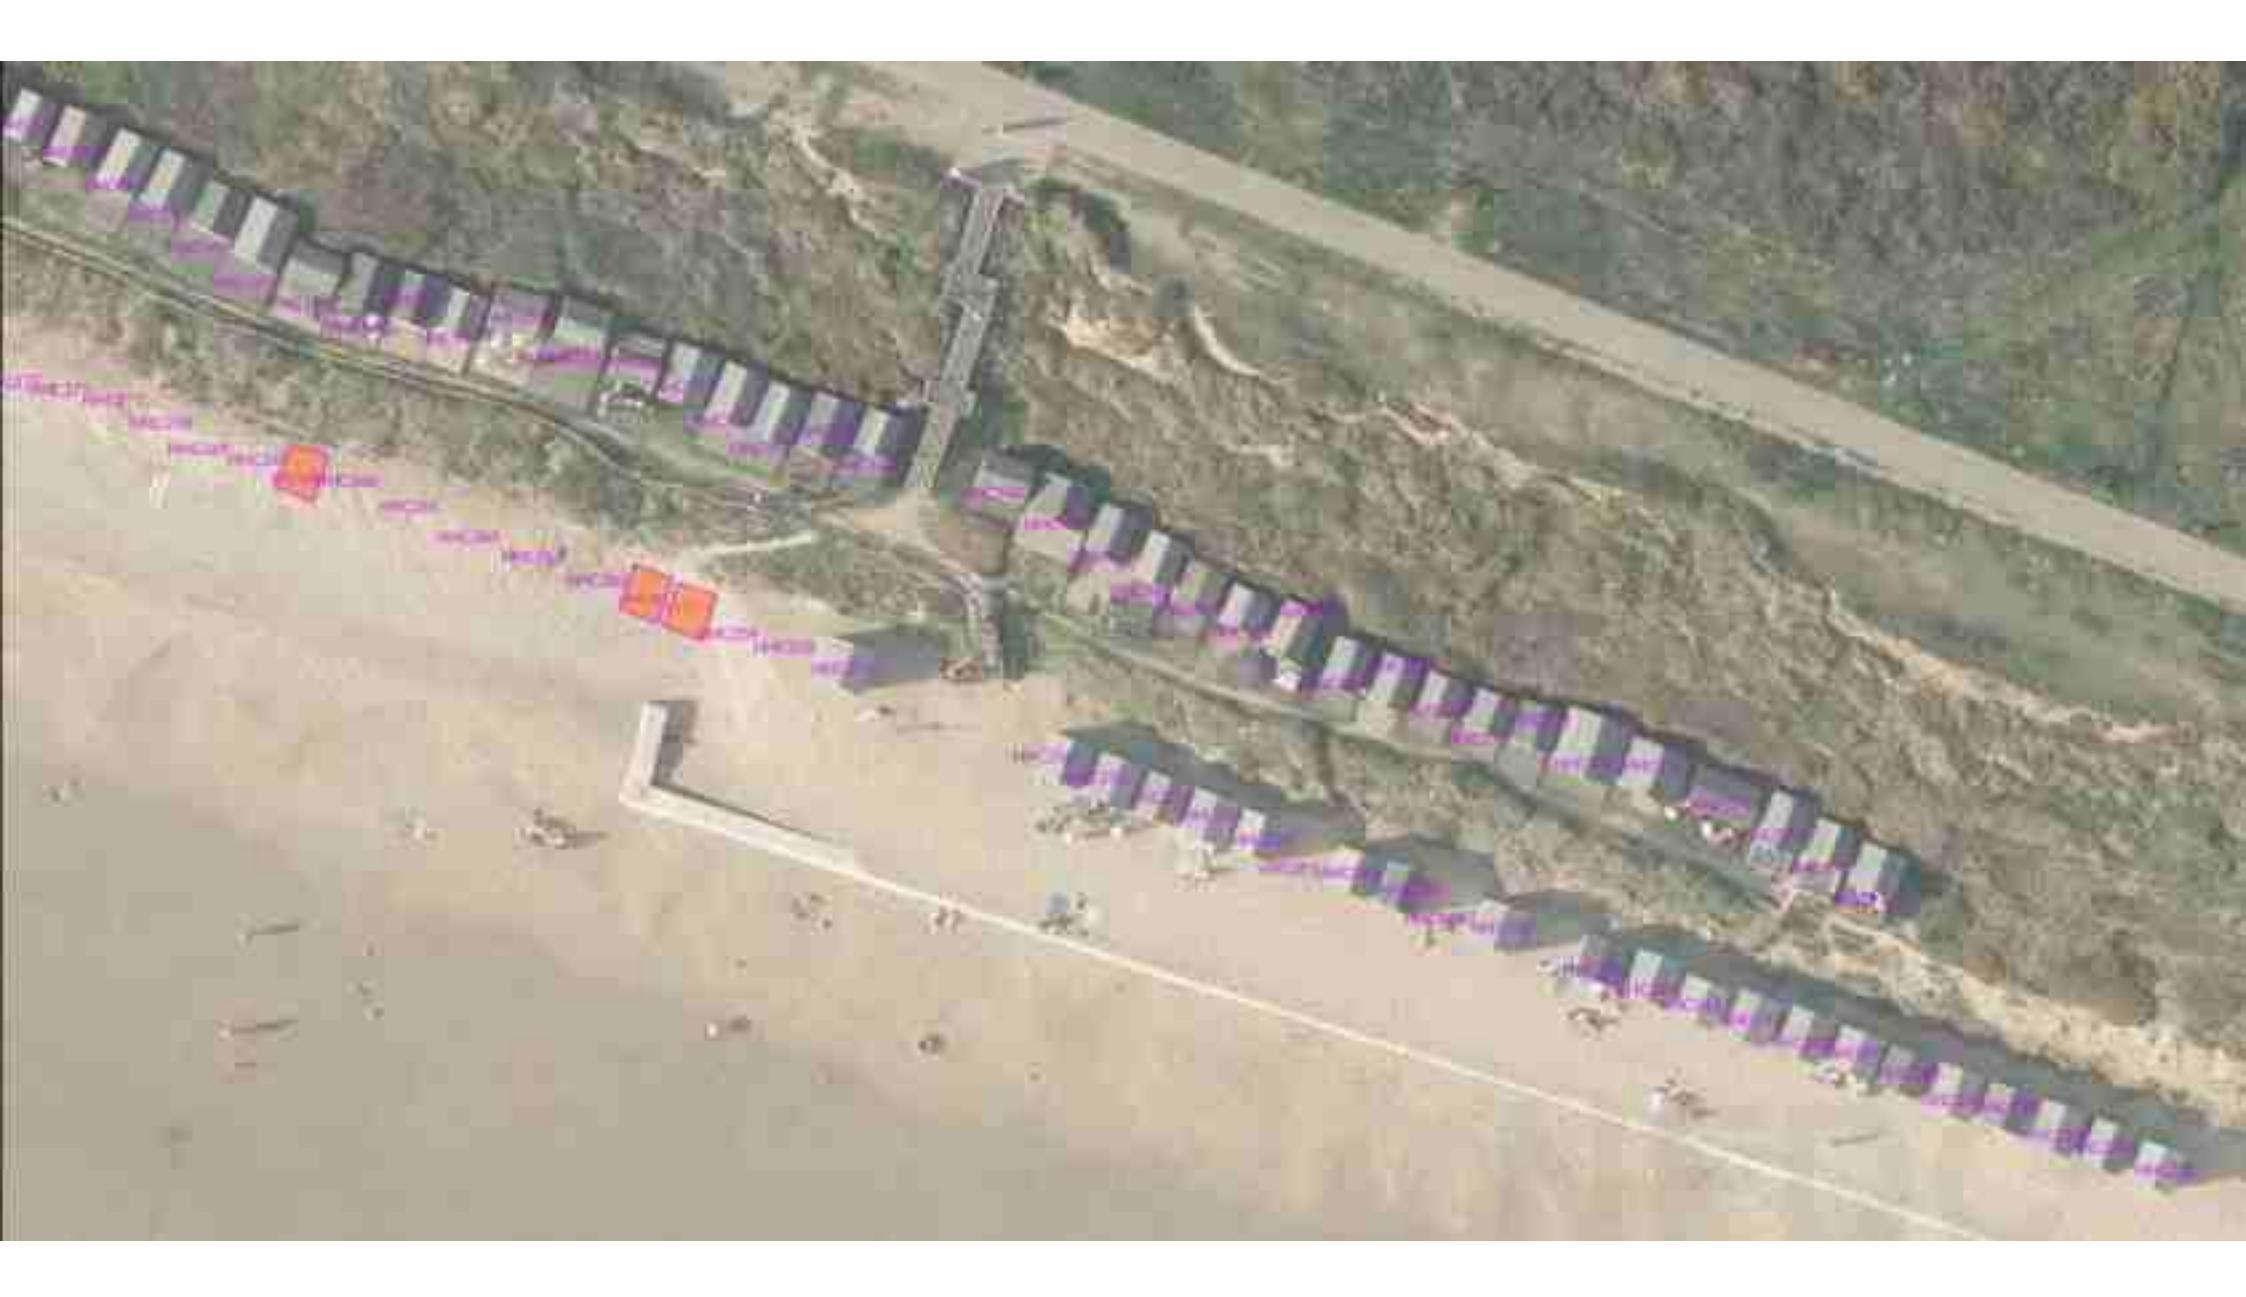
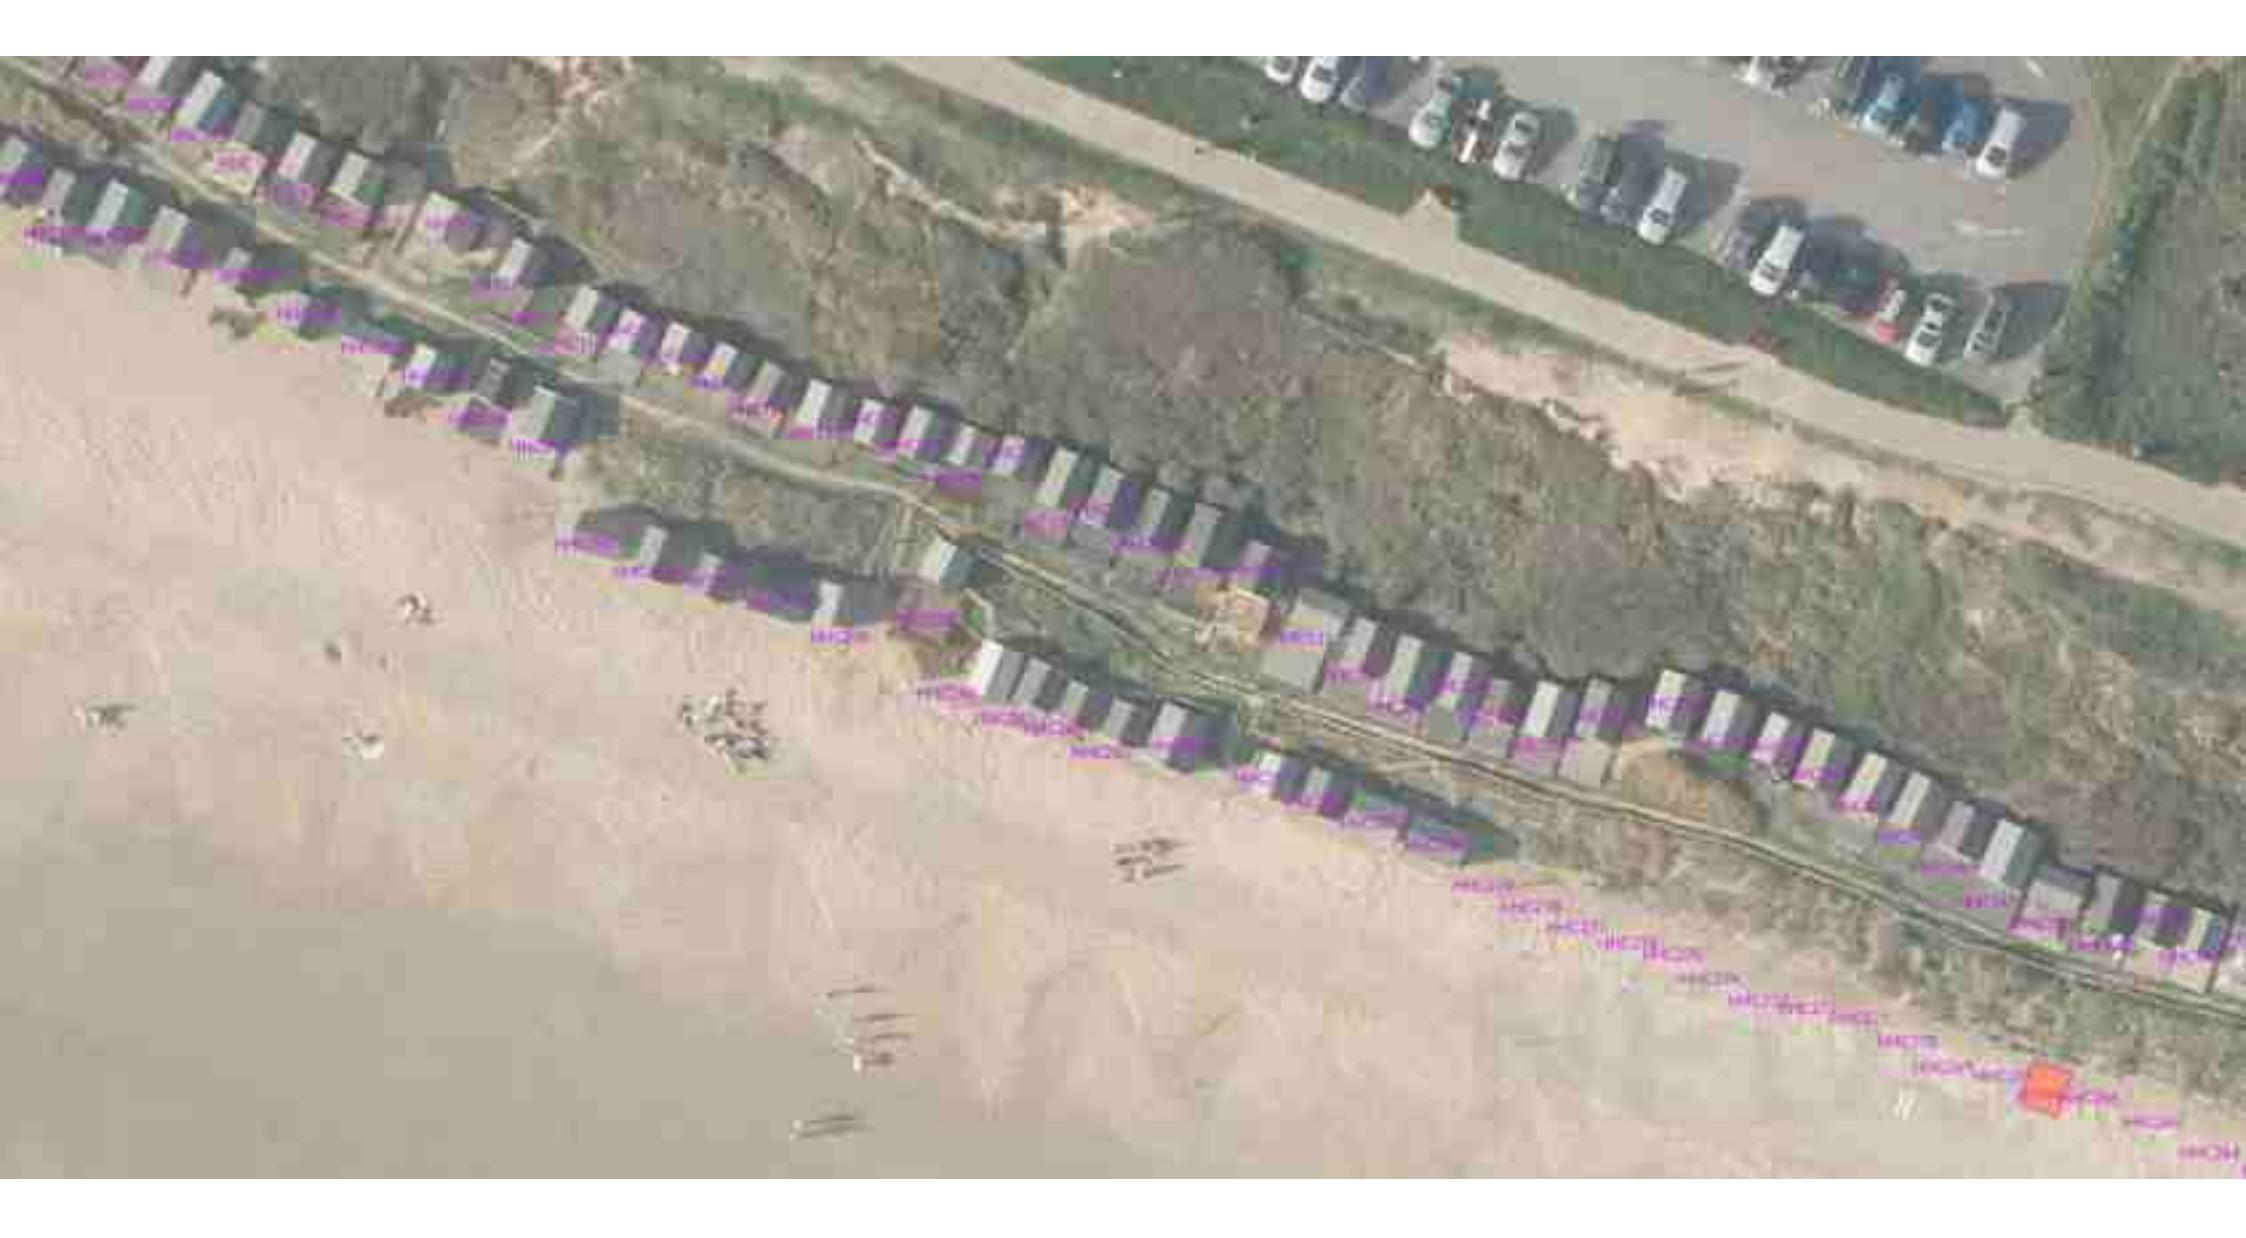
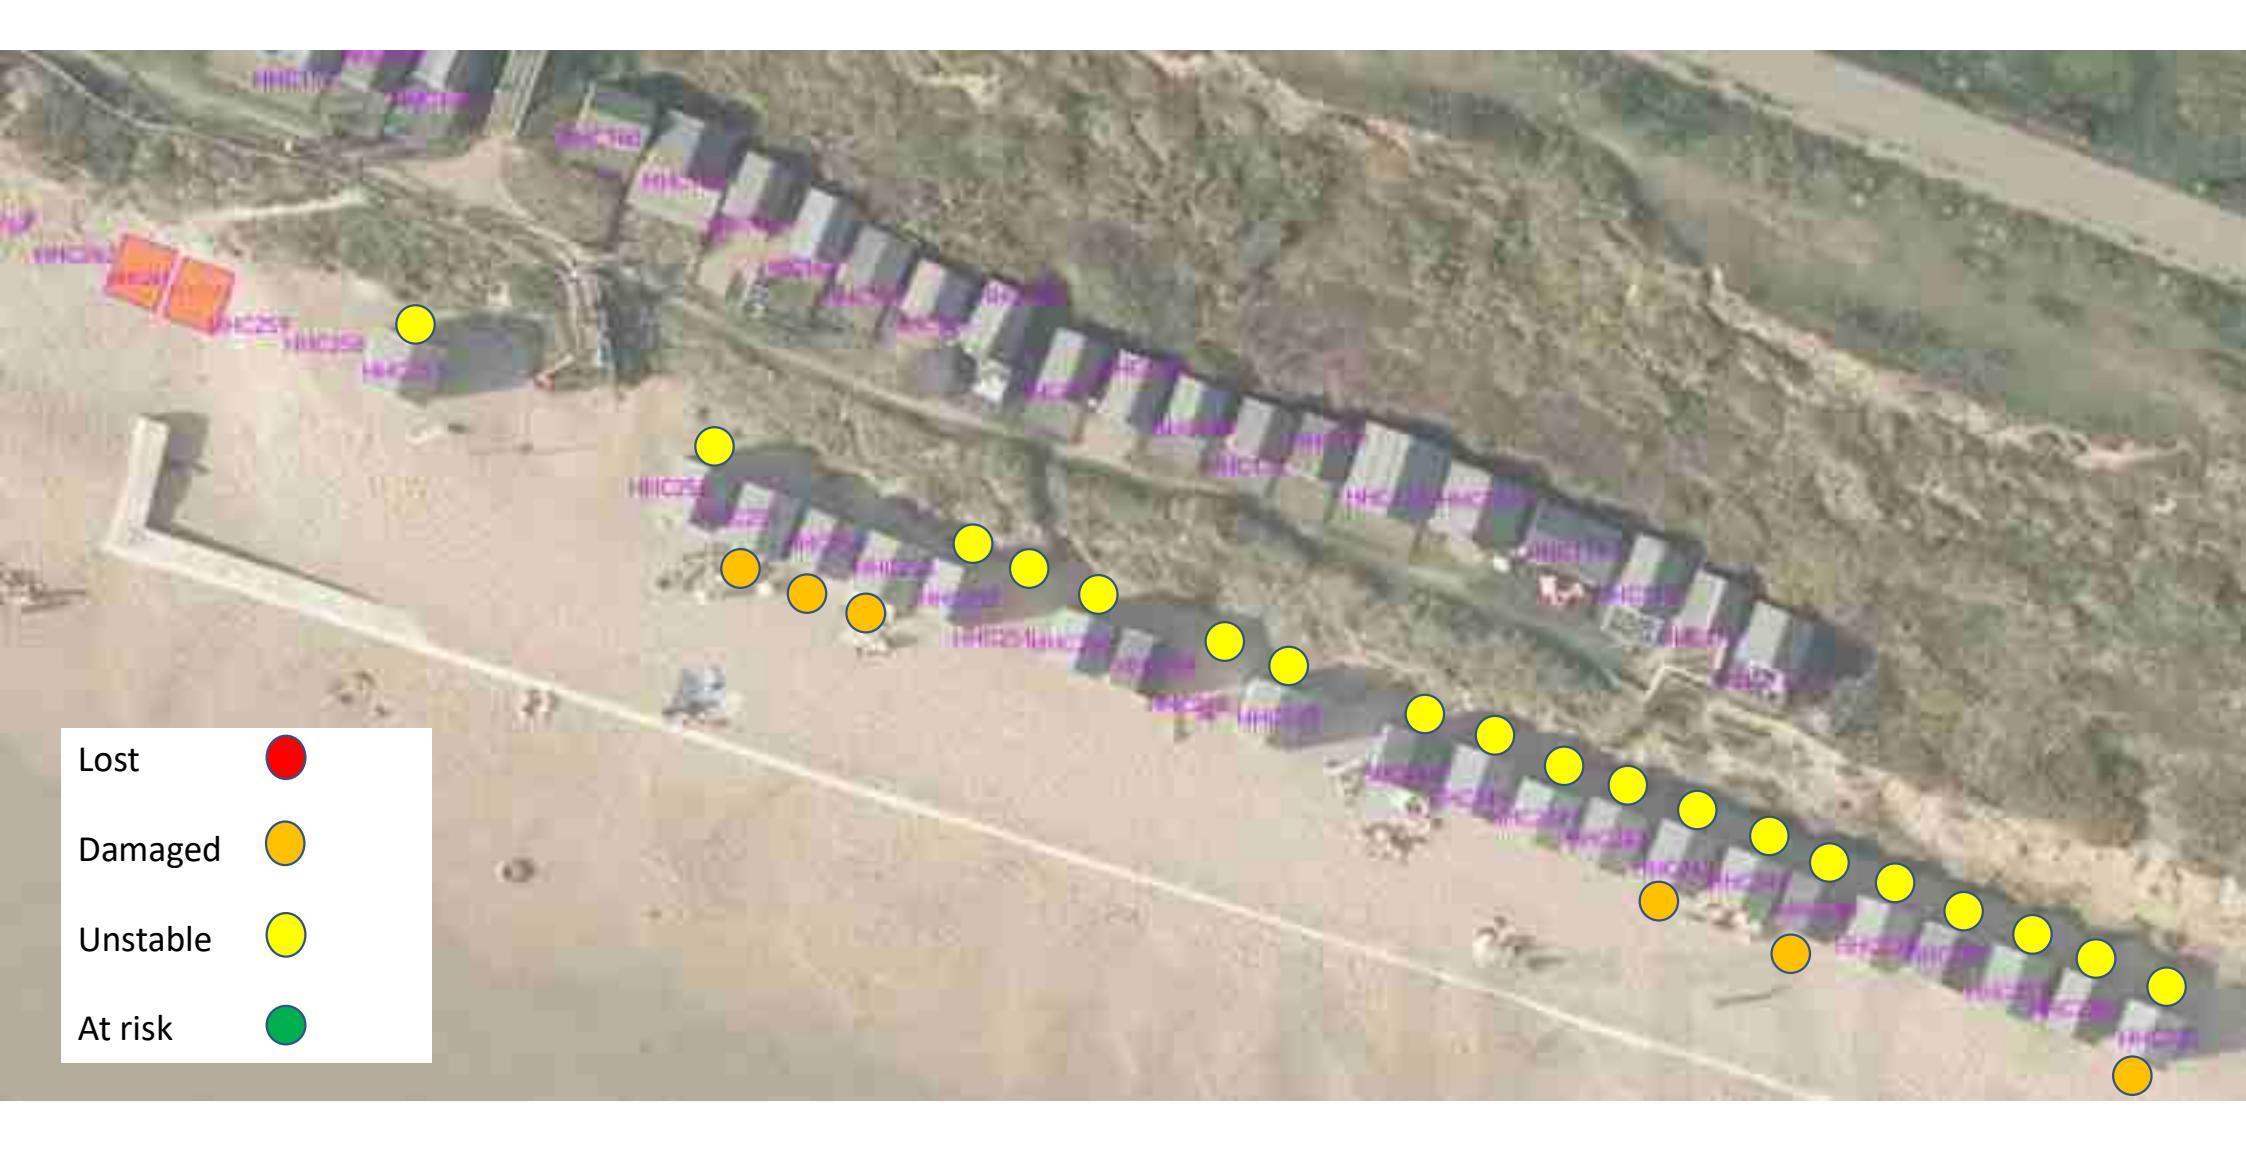
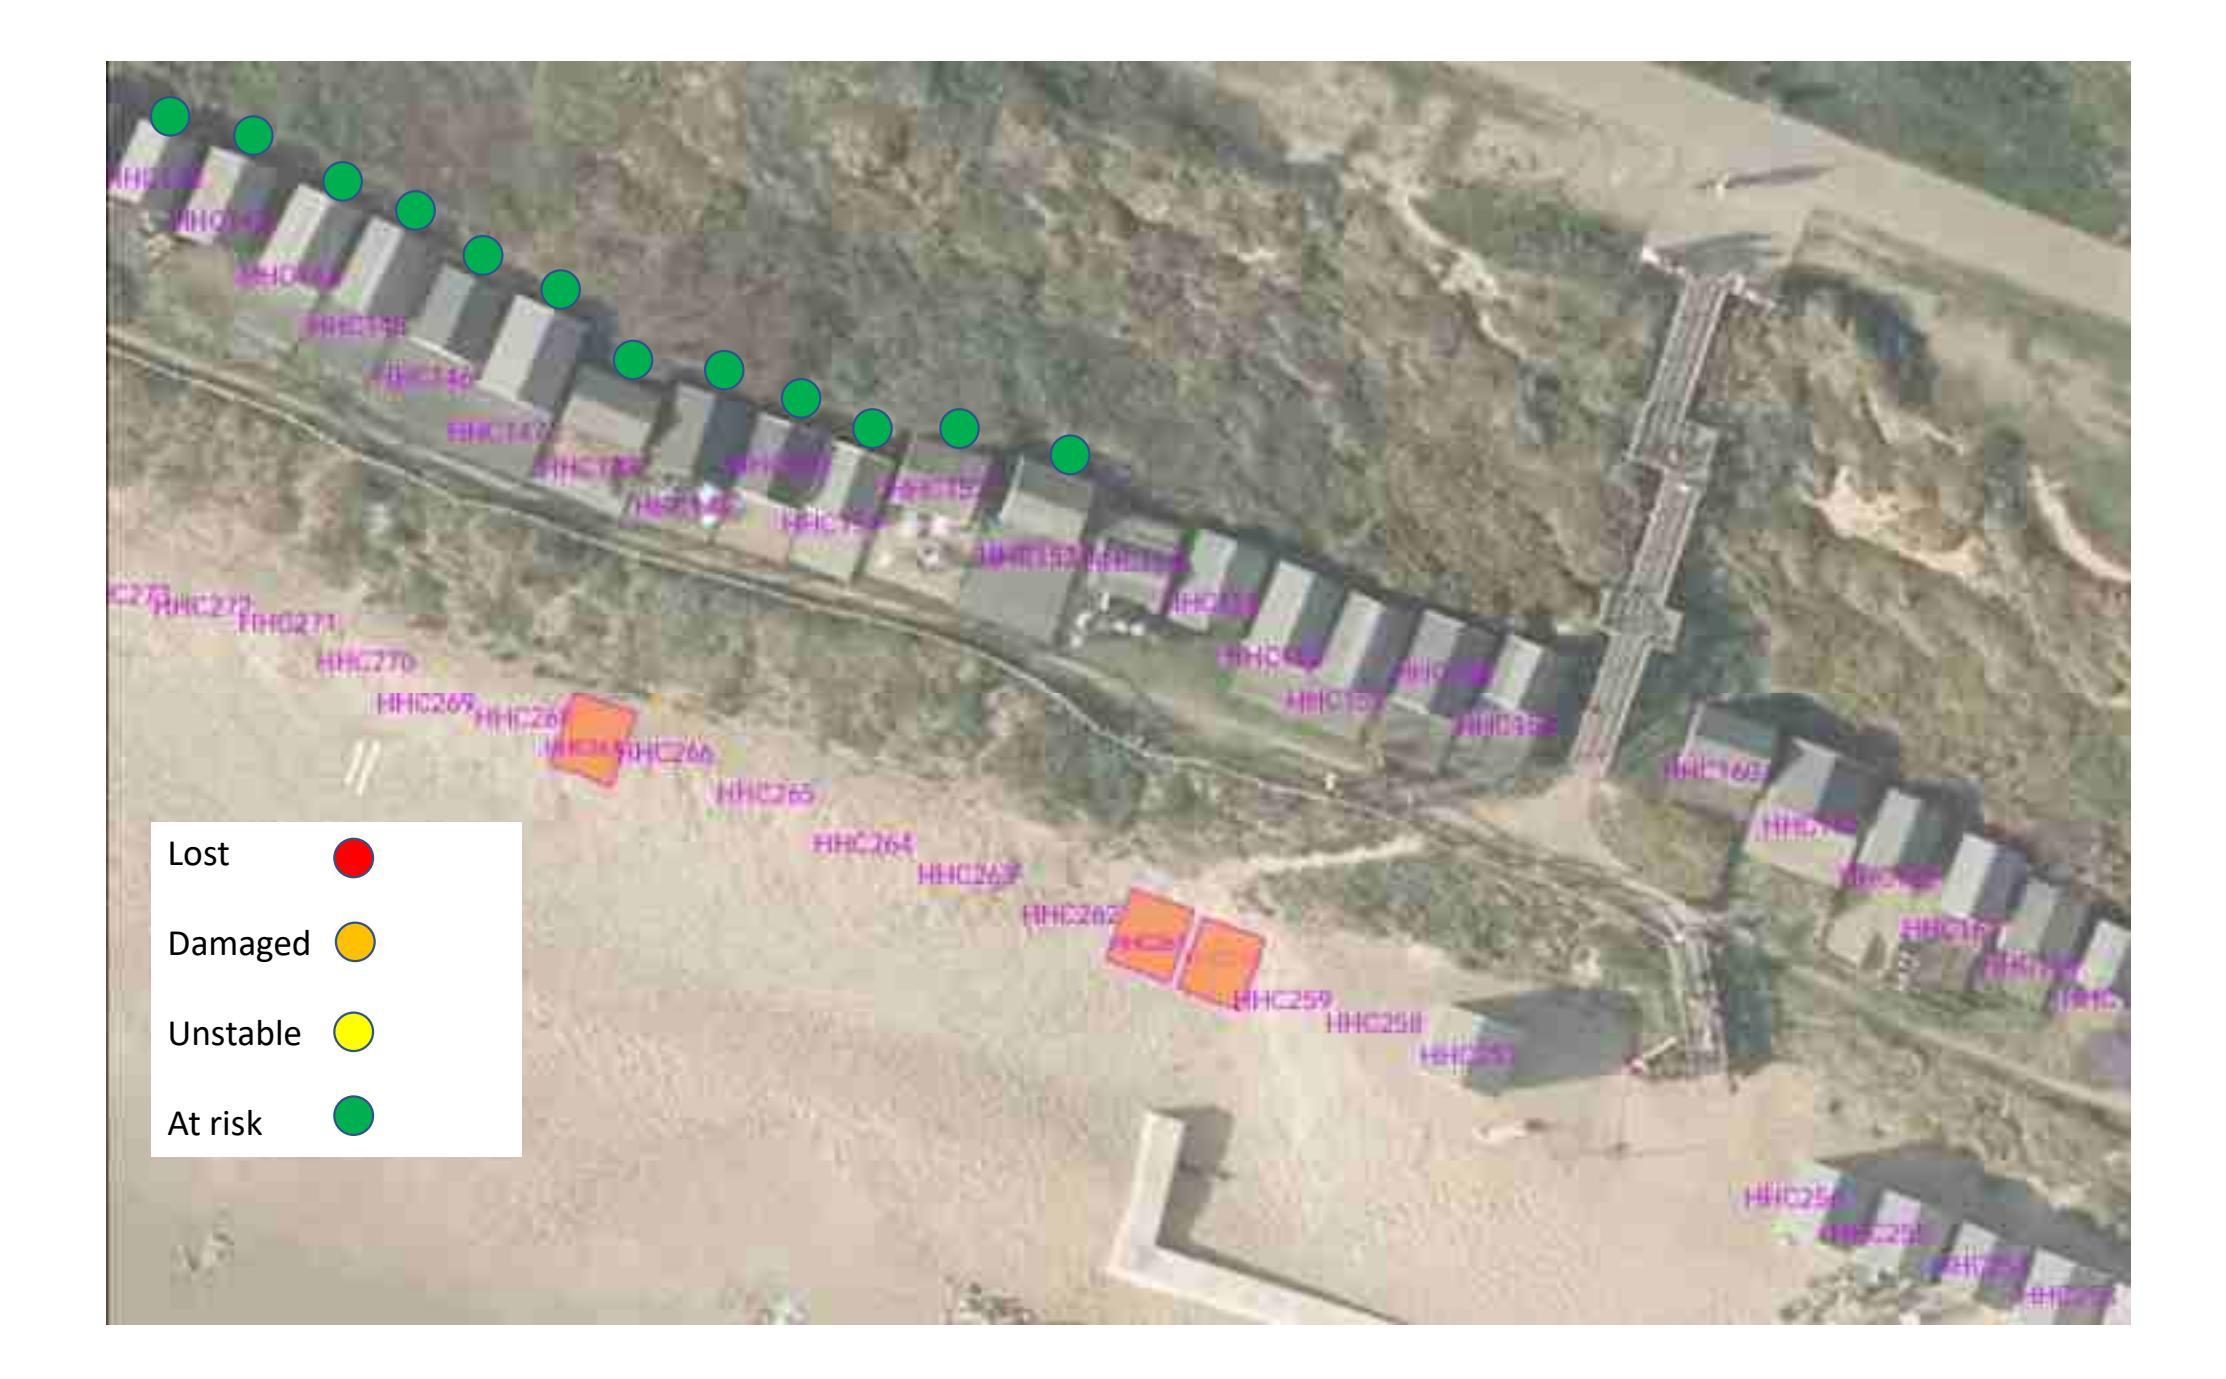
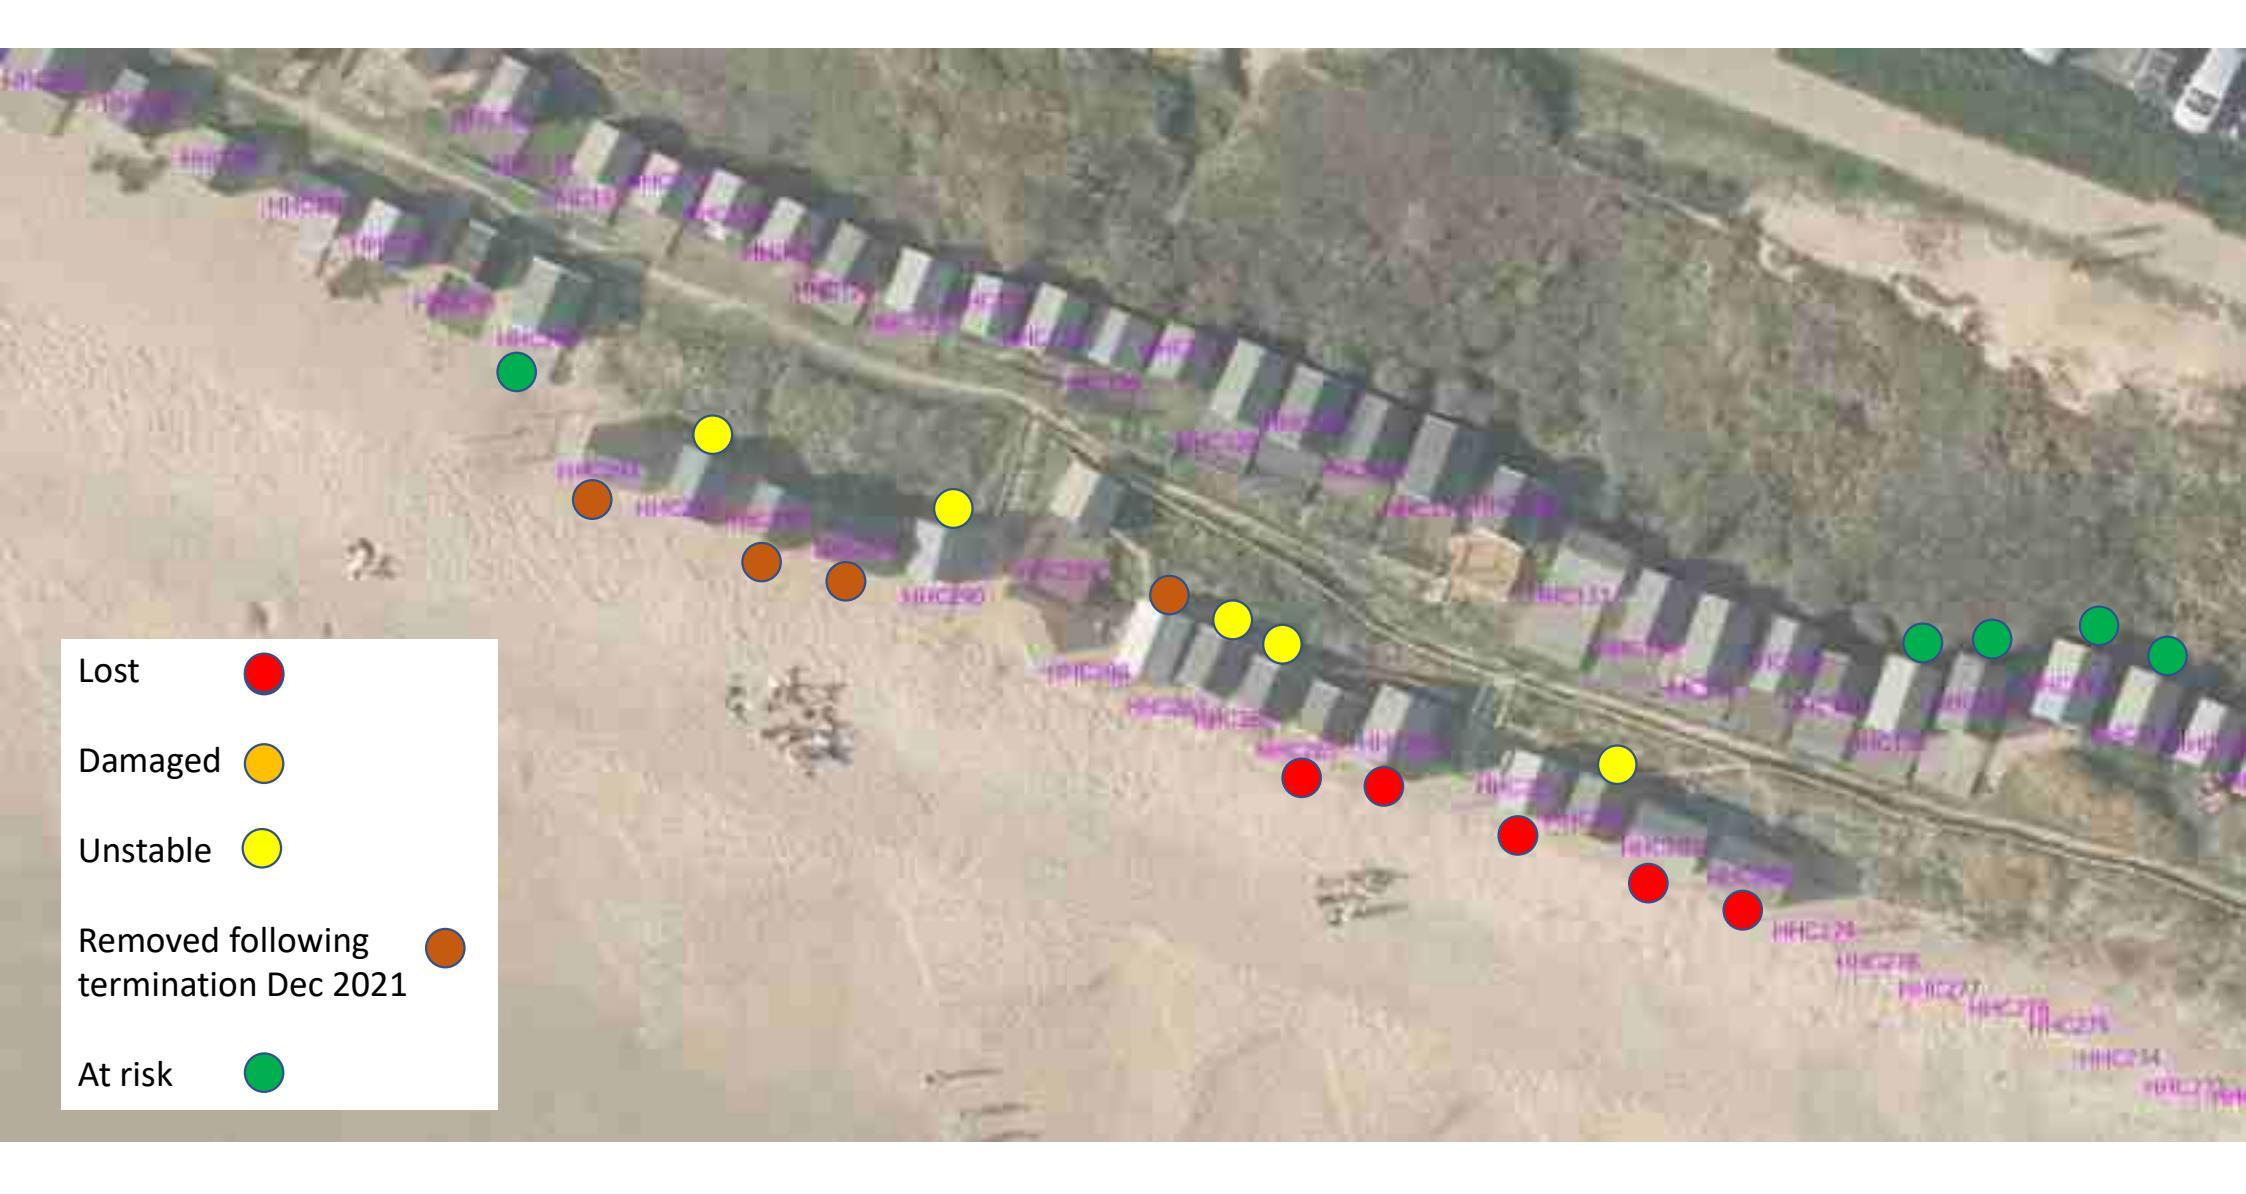
Appendix B – Client Provided Aerial Photographs

Aerial photographs of damaged huts have been provided by the Client (see Appendix B). The beach huts have been marked as lost, damaged unstable, or at risk on satellite photos. Huts that have been removed following termination of licences since the date of the satellite images have also been marked.
